Capital Improvement Study

Town of Seekonk

Massachusetts

Drummey Rosane Anderson, Inc.

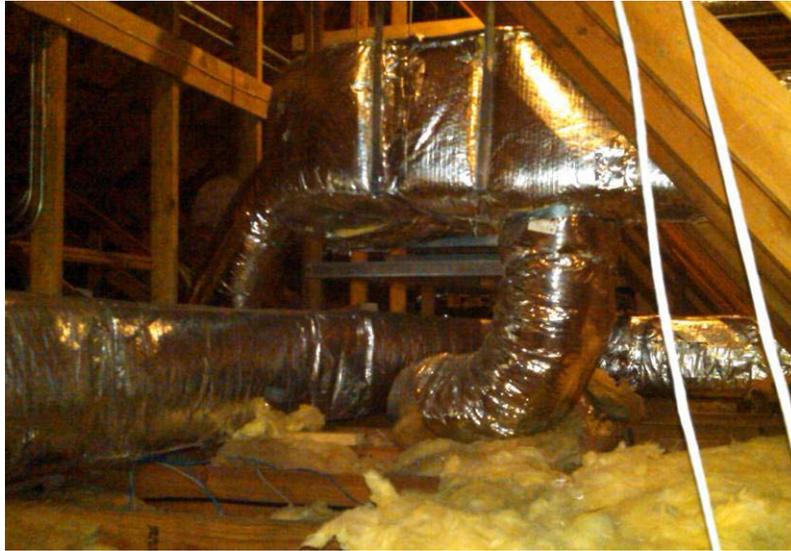
2. Air conditioning is provided via cooling coils provided in the attic mounted HVAC units which receive their cooling from an exterior mounted Electric chiller and condensing units.

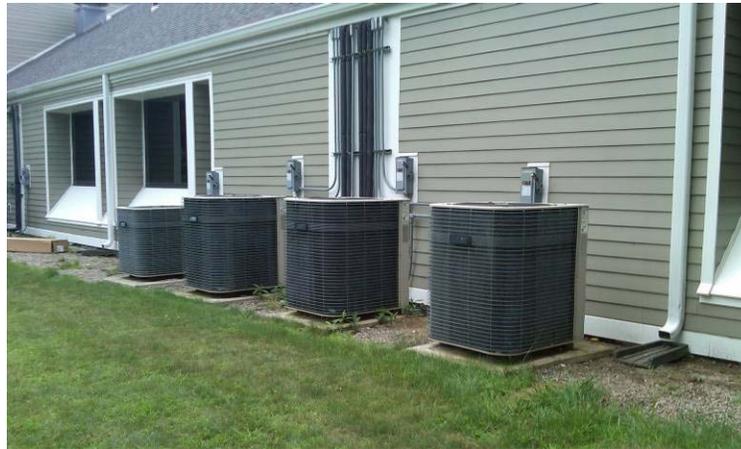
3. The existing temperature controls in the building are via programmable electronic thermostats, these units appear in very good condition and are operating problem free.
4. The present Heating and Ventilating systems consist of a forced air system.
5. Exhaust systems servicing the facility utilize a supply air component within HVAC units.

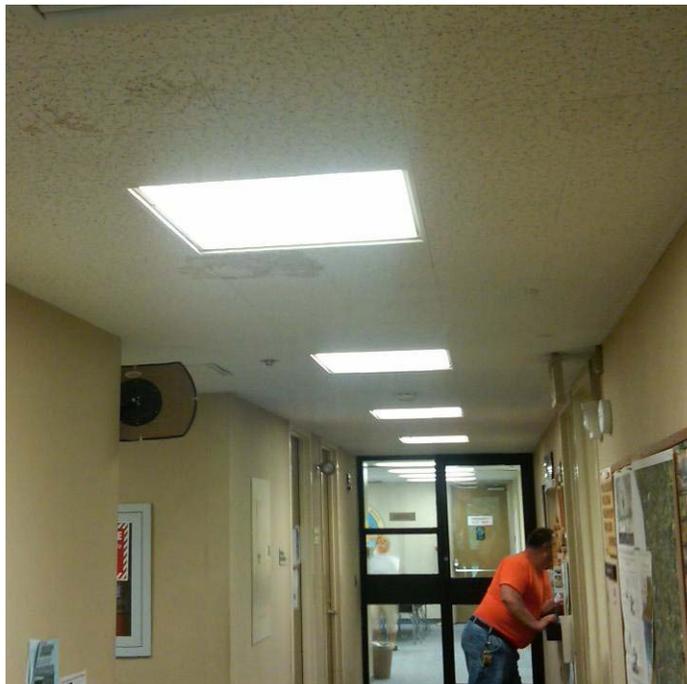
- The fire alarm system is an FCI zoned system. There are manual fire alarm pull stations, horn strobes located throughout the building. Heat and smoke detectors were noted in select areas including smoke detectors in the corridors. Annunciation devices were noted as not conforming to current codes in terms of intensity level requirements.

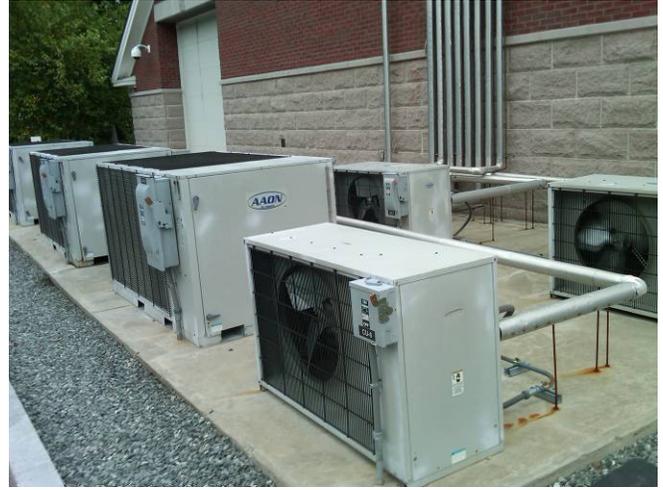
2. The present Heating Ventilating and Air Conditioning systems consist of a ducted air system throughout the building. Selected areas such as the sally port and the apparatus bays are heated by infrared tube heaters. The air-handling units have hot water heating coils, cooling coils, filter sections and exhaust fans.
3. The existing temperature controls in the facility are via electronic thermostats controlling individual air handling units these were noted as operating without issue.

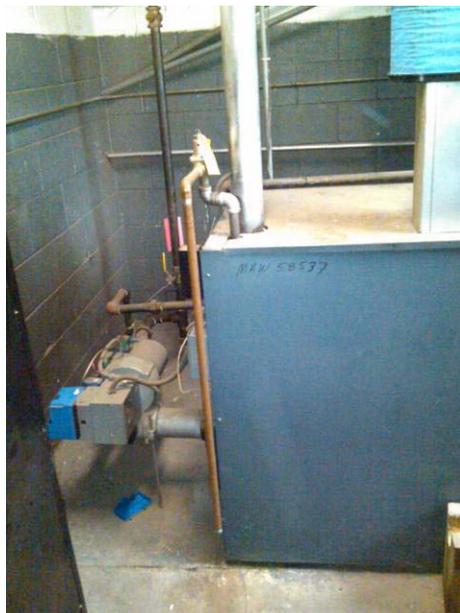
2. The present Heating and Ventilating systems consist of finned tube radiation, hot water unit heaters and exhaust systems. The mechanical equipment is located primarily on exterior walls and in various indoor mechanical spaces within the building.
3. Unit heaters in equipment bays are older and in poor condition. They have begun to fail and repairs are becoming more frequent as they have already exceeded their useful life.

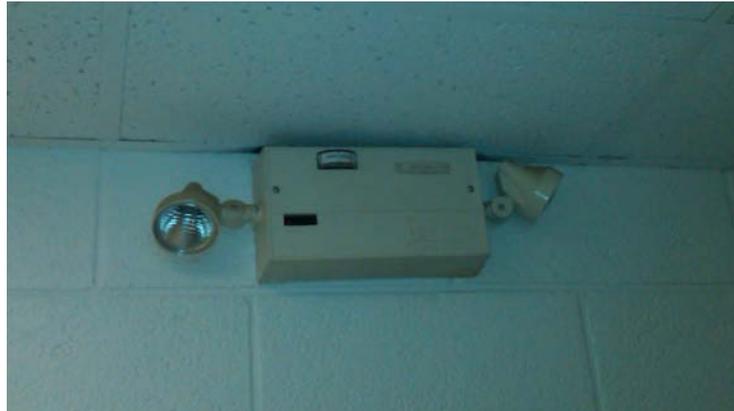
9. Battery powered exit lighting is installed, coverage appears insufficient however and additional units should be installed.
10. There is currently a Security system including magnetic contacts at the main doors and motion sensor detection devices.

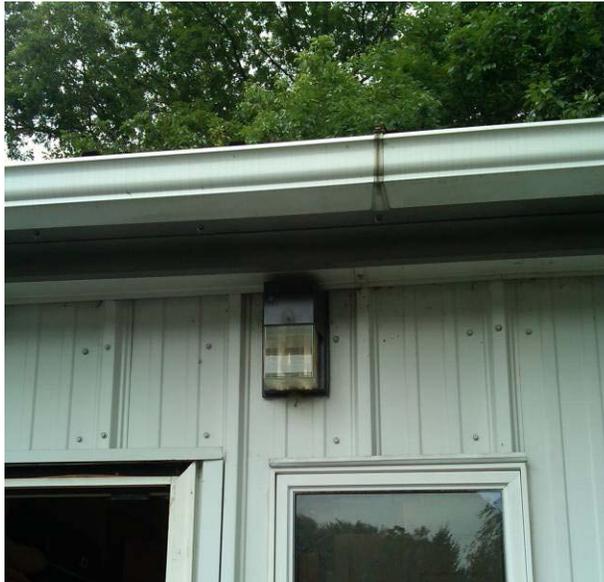
5. There is currently no emergency standby generator located at the facility.
6. Life safety emergency lighting or exit lighting does not exist at the facility.
7. There is currently a Security system including magnetic contacts at the main doors and motion sensor detection devices.

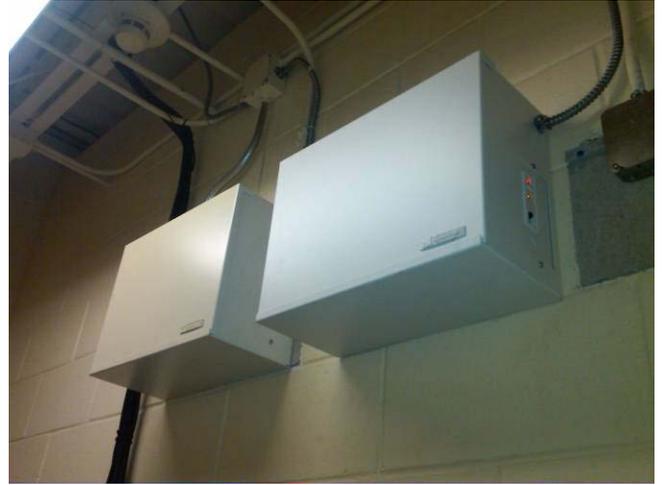
8. Exit lighting is installed throughout, is wired to central battery units as their emergency source and are in good condition.
9. The existing clock system was noted as non-functioning with clocks within the school now operating on batteries.

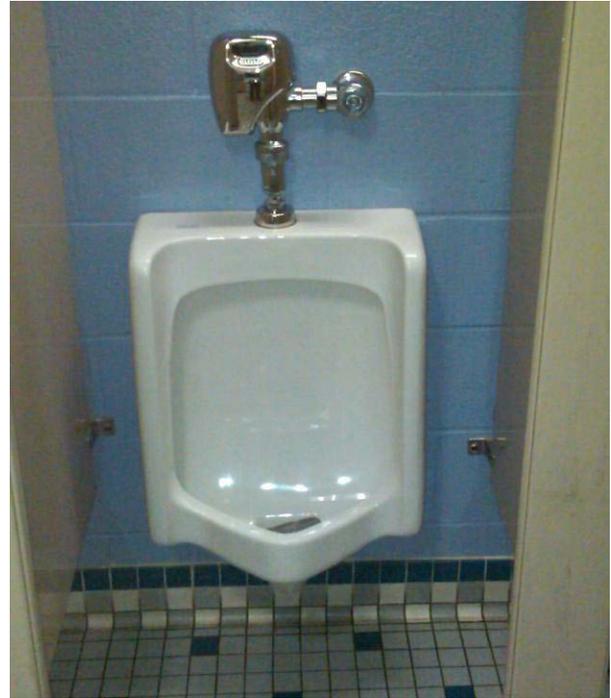
- Urinals are wall mounted vitreous china, with auto flush valve; units appear in very good condition.
- Lavatories are wall hung vitreous china. Faucets are single lever handle auto type, units appear in very good/good condition.
- Drinking fountains are surface mounted stainless steel dual level units a few older Vitreous china recess mounted unit do exist. Most appear to be ADA compliant, and are in very good condition.
- Typical classroom sinks are counter top, stainless steel units with dual lever gooseneck faucets. Most appear to not be ADA compliant.
