SEEKONK PUBLIC SAFETY FACILITY

SEEKONK, MASSACHUSETTS

EXISTING CONDITIONS & DEMOLITION PLAN

1 of 6
C-1

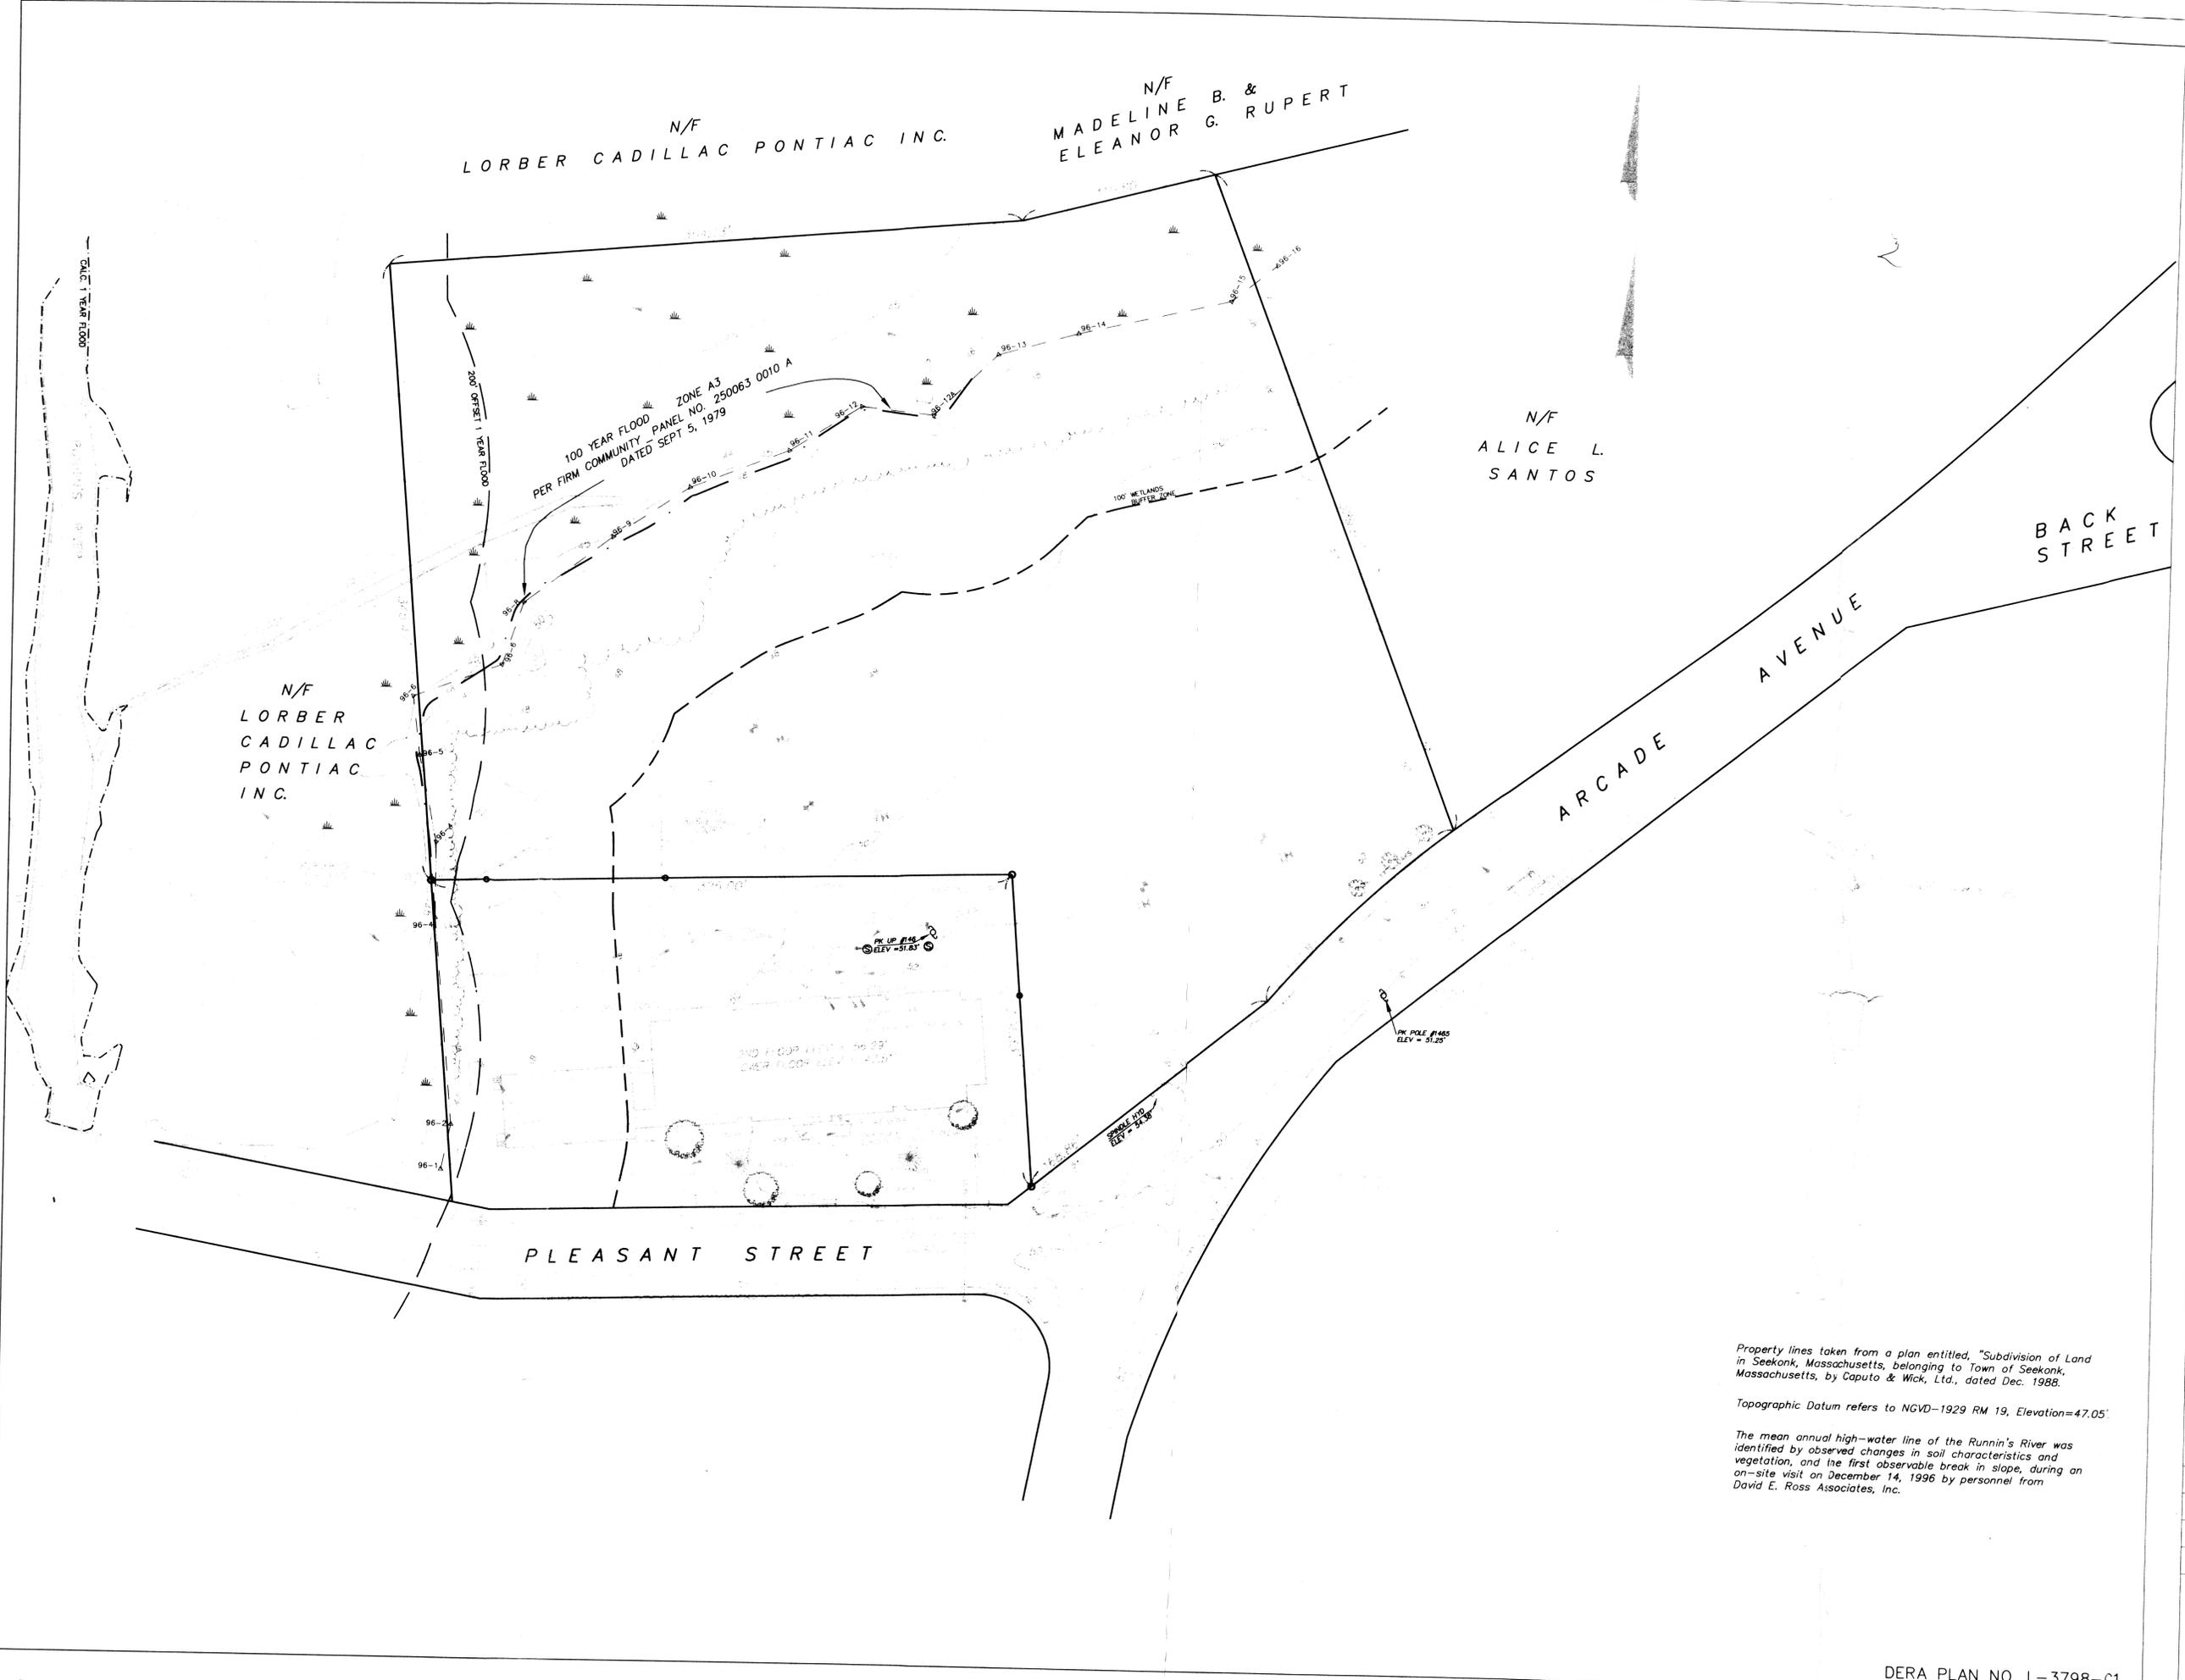
Property lines taken from a plan entitled, "Subdivision of Land in Seekonk, Massachusetts, belonging to Town of Seekonk, Massachusetts, by Caputo & Wick, Ltd., dated Dec. 1988.

Topographic Datum refers to NGVD-1929 RM 19, Elevation=47.05'

The mean annual high-water line of the Runnin's River was identified by observed changes in soil characteristics and vegetation, and the first observable break in slope, during an on-site visit on December 14, 1996 by personnel from David E. Ross Associates, Inc.
