Capital Improvement Study

Town of Seekonk

Massachusetts

Drummey Rosane Anderson, Inc.

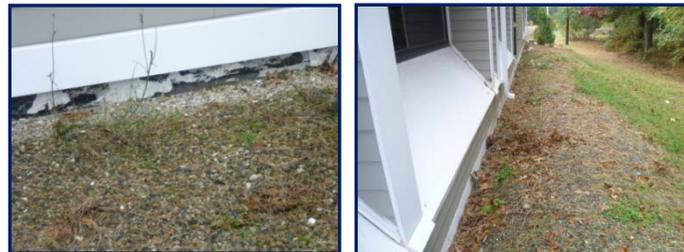
4 SITE GRADING. Grade around Building slopes towards foundations; this can be corrected by re-grading to provide drainage to flow away from the building.

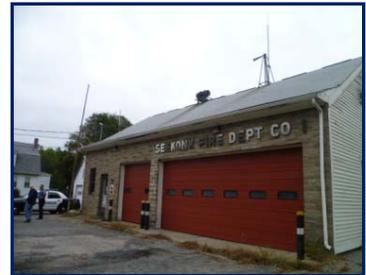
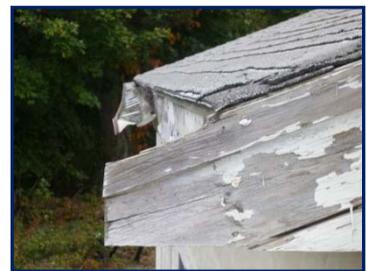
1 RECOMMENDATION. We need to know what the use would be if renovated. If it will remain a storage building we recommend that it be demolished and a new metal structure be erected. However, we do not believe that a metal building should be located in this residential neighborhood.

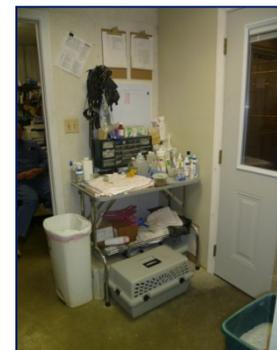
2 SPACE / CONFIGURATION ISSUES. The office area of the building is overcrowded. Animal cage banks (cats) have had to be located in office and work areas due to space restrictions but should have their own separate space. The medical station that currently consists of a small table is grossly inadequate. Any available space within the building and the two out buildings have had to be used as storage space. The plastic storage units should be removed. Separate storage spaces should be provided for animal food, medical supplies and general supplies. Out buildings are not accessible and should be limited to animal carriers, traps and similar non-perishable items. There is no separate space for the public. An expansion would be necessary to overcome these issues. Dog pens require natural light, but there are only two minimally sized windows into the entire space. Pens backing up to the fenced in outdoor area should have doors to allow dogs to go directly to the exterior.

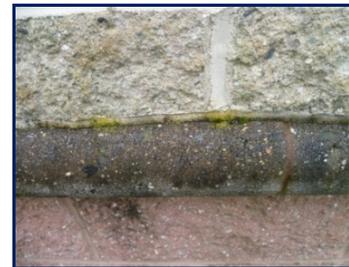
3 EXTERIOR MASONRY. Concrete masonry units (CMU) are badly soiled and moss is growing on ledges. We recommend that the CMU be cleaned and a sealer applied to wall to reduce future soiling.

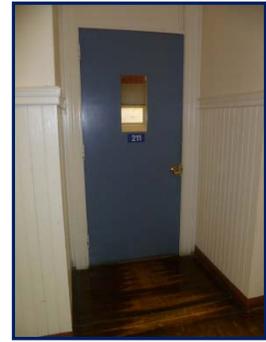
1A ACCESSIBILITY. There are many ADA violations throughout the building. For example; knob sets on doors, projecting nosings on stairs; large diameter handrails without extensions.

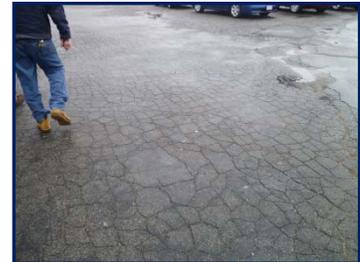
1 SITE PAVING. Virtually all of the pavement on the property should be replaced. Curbing improvements should be installed throughout the site to provide more defined curb cuts onto Pleasant Street.

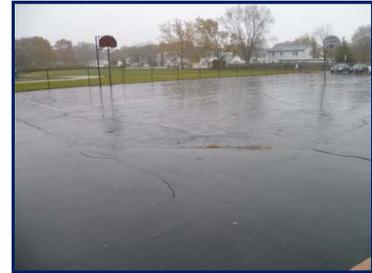
replaced Sidewalks should be patched at curbing to remove tripping hazard.

3 SITE PAVING. Bituminous paving around building is badly cracked and in areas should be

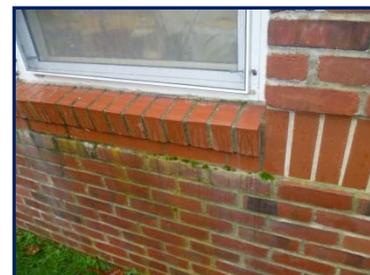
4 WINDOW GLAZING. Many windows are glazed with polycarbonate on the exterior and glass on the interior and, overtime, have become obscure. There are a number of options starting with total replacement to just replacement of the center section of polycarbonate. Units could also be replaced with low-E glazing to improve both visibility and energy efficiency. Our recommendation is to replace only those windows that open into staff workrooms.

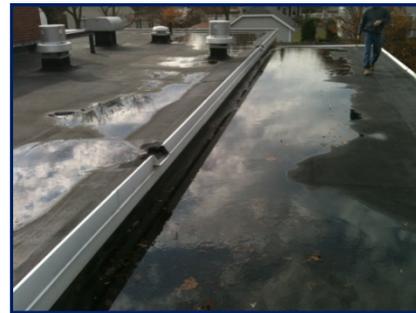
2 ROOFING SYSTEM. EPDM roofing on center section is 20 years old and has had some leaking problems. Slope is minimal and drainage to perimeter scuppers poor. There is much ponding as water cannot get to scuppers. The roof consists of a fully adhered EPDM membrane on 1 ½" of poly-isocyanurate insulation on the original built-up roof comprised of gravel and 5 plies of asphalt roofing on a tectum deck. The insulation level (approx. R=14) is inadequate and should be increase for energy savings. The roof should be replaced with a tapered insulation system. Flashings at walls will need to be replaced and possibly raised.

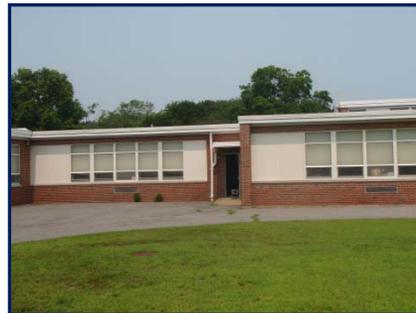
2 EXTERIOR MASONRY. Below fascia of new wing there is damaged brick around regularly spaced fasteners. A new longer fascia should be installed over these fasteners to prevent further brick deterioration.

2 MASONRY REPOINTING. Window sills on the original building need to be re-pointed.

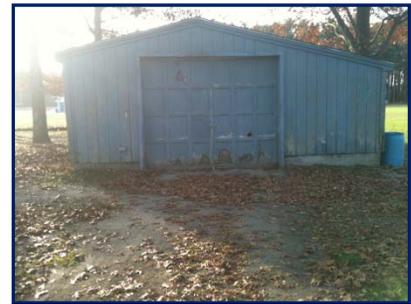
1 MAINTENANCE STORAGE. Maintenance equipment is currently stored in a former chicken coop. The space is not adequate and the exterior siding is badly deteriorated. It is recommended that this building be replaced with a building more suited to the storage and access to the maintenance equipment.

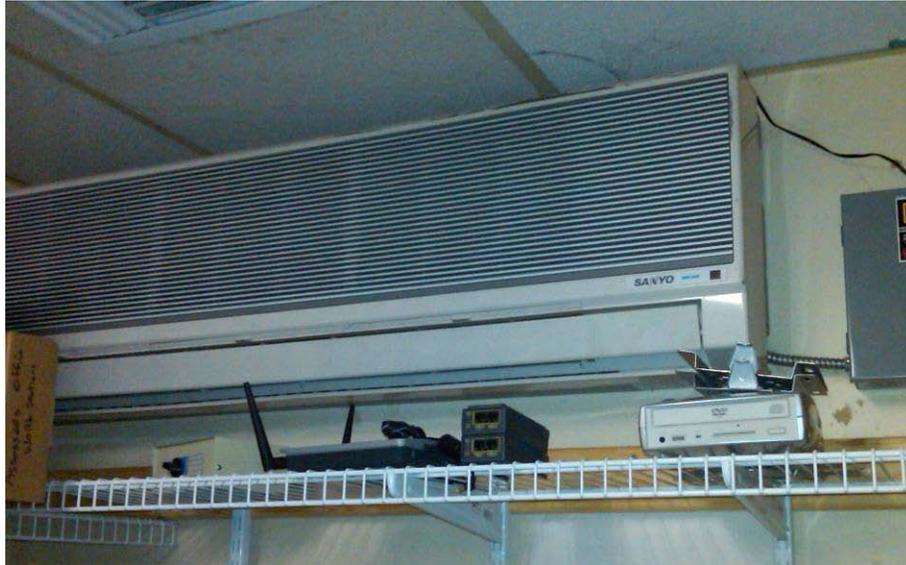
6. A dedicated split system A/C unit is provided in the computer room.

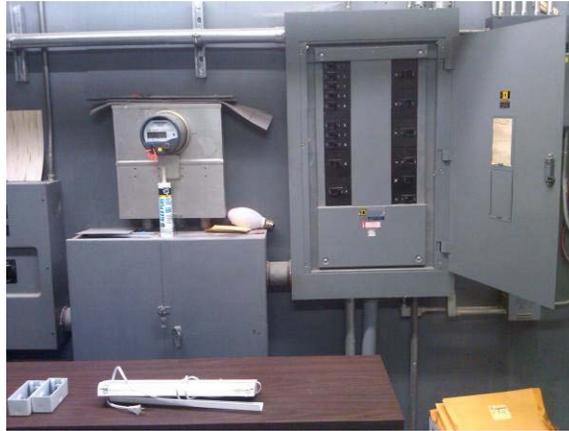
1. The building is served by a single electrical service rated 400 amperes, 208Y/120volts, 3-phase, 4-wire and is located in the main electric room. The service equipment consists of utility company pole mounted transformers, an underground feed to utility metering equipment a 400amp main disconnect switch and distribution panel located in the main electric room. The predominance of the main distribution equipment service equipment is newer and in very good condition.

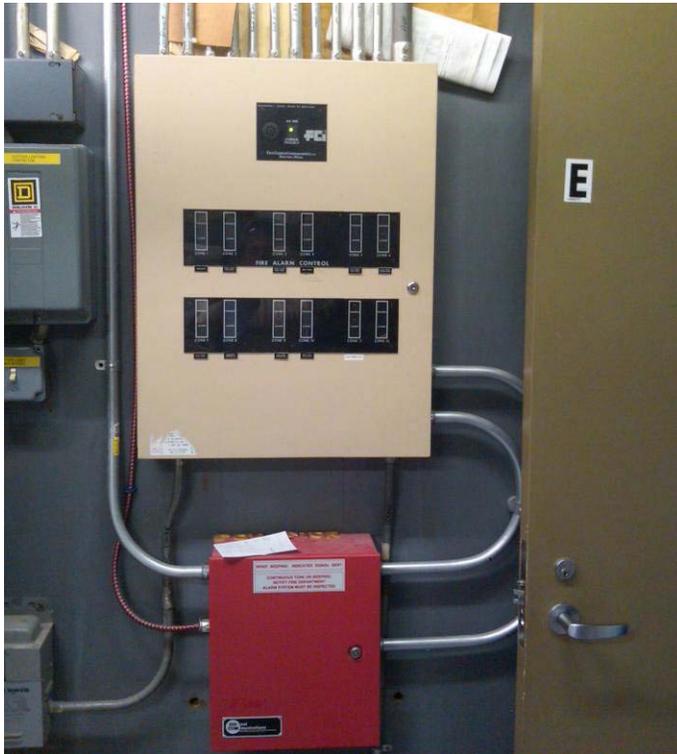
- The fire alarm system is an FCI zoned system. There are manual fire alarm pull stations, horn strobes located throughout the building. Heat and smoke detectors were noted in select areas including smoke detectors in the corridors. Annunciation devices were noted as not conforming to current codes in terms of intensity level requirements.

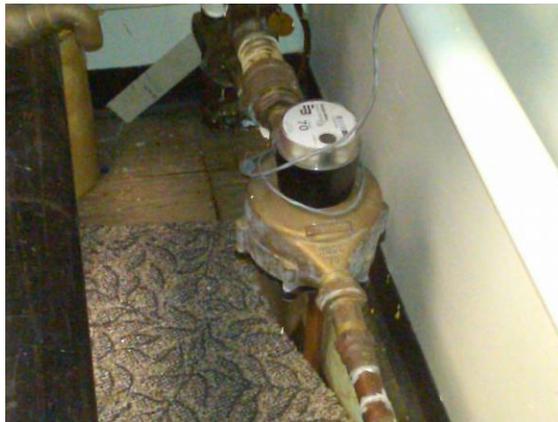
- a. Existing Domestic Water Service: The existing building is currently served by a 1-1/2" inch domestic water service located within the fire service room. The domestic water service equipment includes a water meter and isolation valves. This water service currently serves all of the facilities domestic water needs. The water distribution system is original to the building and each subsequent addition/renovation.

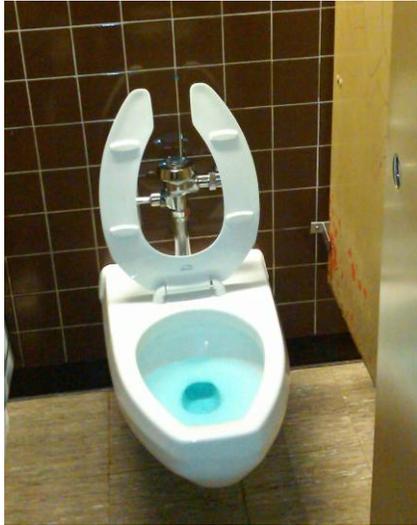
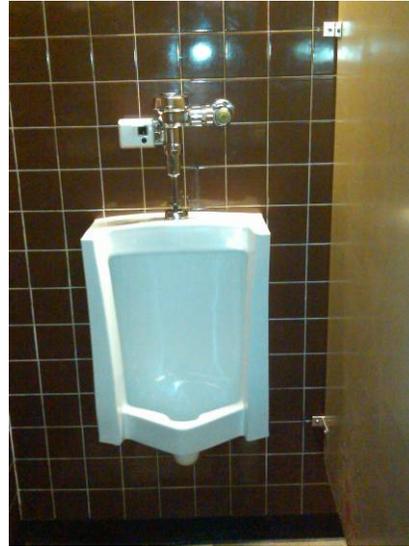
- Water closets are floor mounted; manual flush valve, vitreous china. Fixtures appear new and in very good condition.

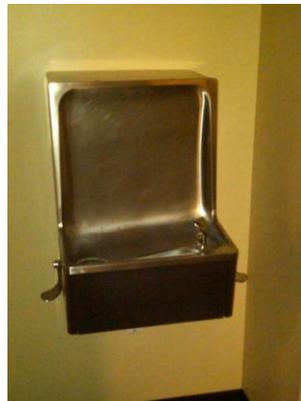
- Urinals are wall mounted vitreous china, with auto flush valves. Fixtures appear new and in very good condition.
- Lavatories are wall hung vitreous china. Faucets are of the dual lever handle type. Fixtures appear to be new and in very good condition
- Drinking fountains are surface mounted stainless steel units. Most appear to be ADA compliant, and are in good condition.

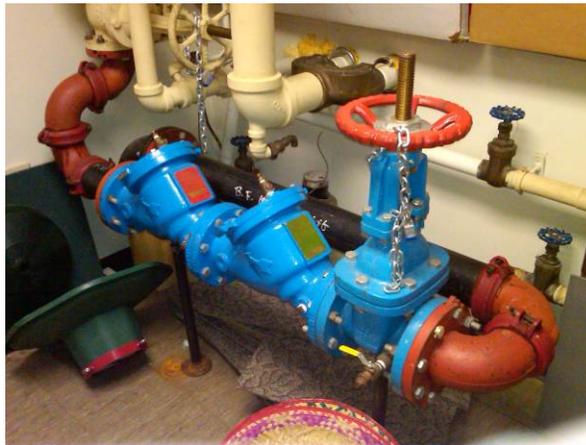
1. There is a complete fire protection (sprinklers) system in the facility. Coverage appears to cover all areas of the buildings. The system is complete with all back flow prevention devices and fire alarm system monitoring.

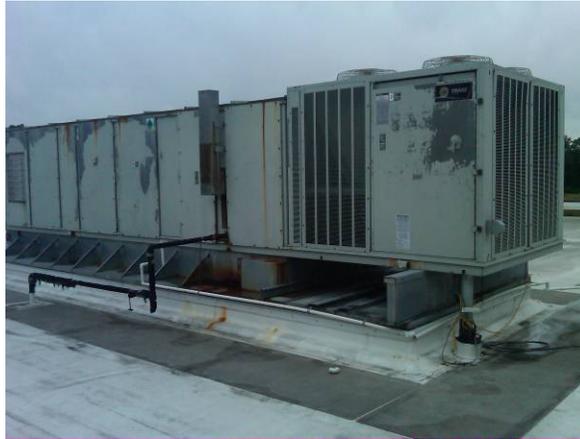
1. The existing building is heated and cooled by a single packaged roof top unit. This unit is approximately 17 Years old Heating is furnished via gas. This unit was noted by operations personal as having ongoing maintenance issues. The physical condition of the unit appears fair for its age although it is approaching its life expectancy.

In general, the systems vary in age from original to the building (30+ years old), to as recent as 2-3 years old. Some equipment such as the existing Roof Top Unit and the controls system have been problematic, have reached or are approaching the end of their useful life expectancy and should be replaced in order to improve the reliability, efficiency and to cut down on the operational and maintenance costs associated with the heating and cooling system.

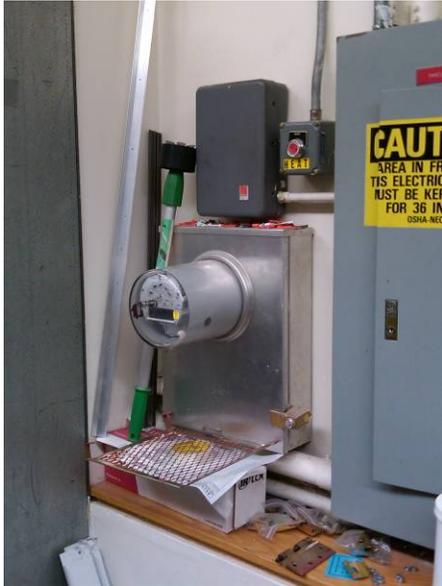
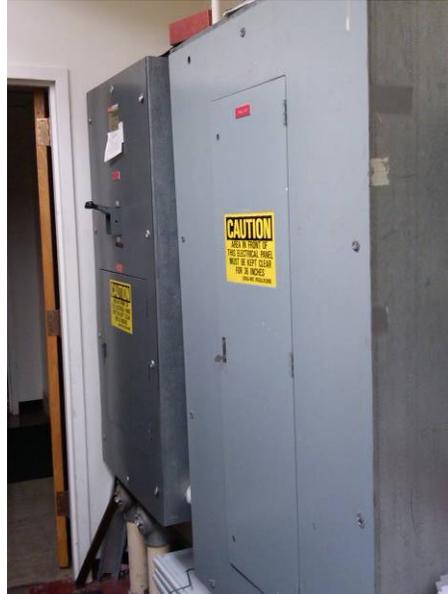
1. The building is served by a single electrical service rated 800 amperes, 208Y/120volts, 3-phase, 4-wire and is located in the main mechanical room. The service equipment consists of utility company transformer, an underground feed to utility metering equipment an 800amp main disconnect switch and main distribution panel located in

the mechanical room. The predominance of the main distribution service equipment is newer and in very good condition.

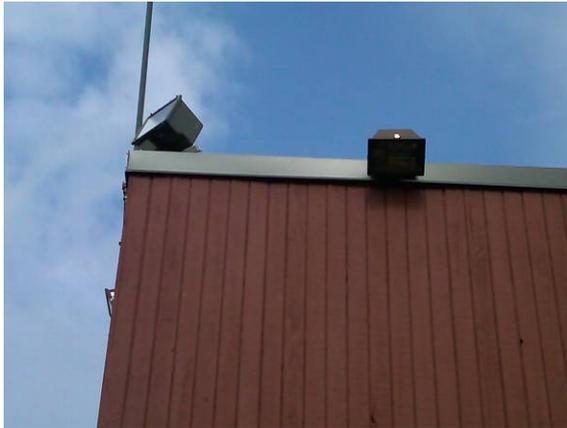
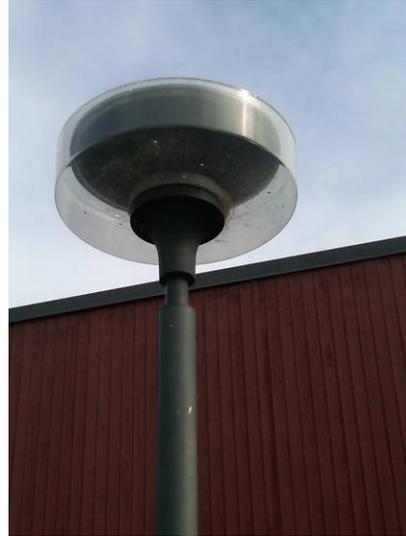
5. Site lighting is accomplished via building mounted wall packs, flood lights and a number of pole mounted fixtures all appear to be in good condition.

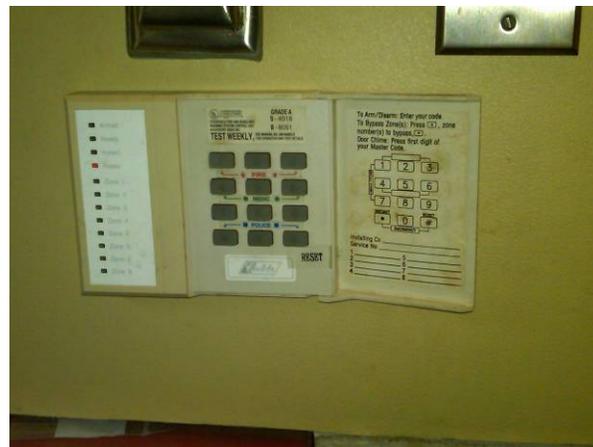
6. There is no on site emergency standby generator located at the facility.
7. Life safety emergency lighting is provided via emergency battery units with unit mounted light heads. These units are newer in very good condition and appear to provide sufficient coverage throughout the facility.
8. Battery powered exit lighting is installed throughout, and is in good condition.
9. An existing paging system is installed believed to be newer and is in very good condition with no noted problems.
10. There is currently a Caddy security system including cameras at select locations, magnetic door contacts at all the exterior doors. The system was noted as functioning without any issues.

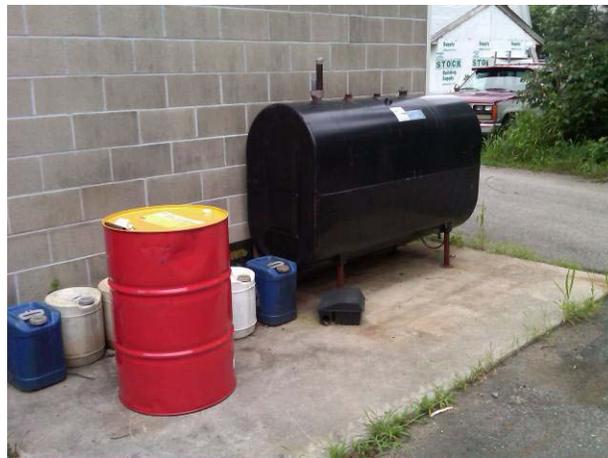
4. Fuel Oil:
 - a. There is currently a 330gallon above ground exterior fuel oil tank located at the rear of the building. This tank appears to be in good condition, it was noted that this tank serves the existing oil fired boiler.

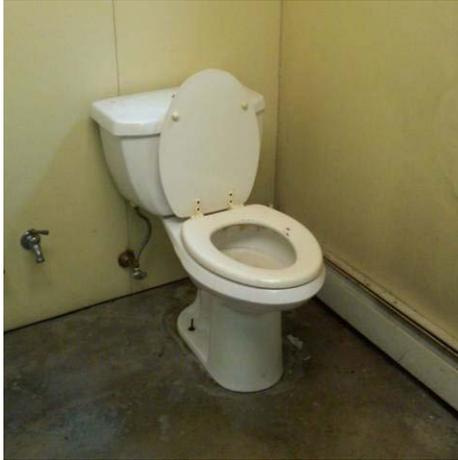
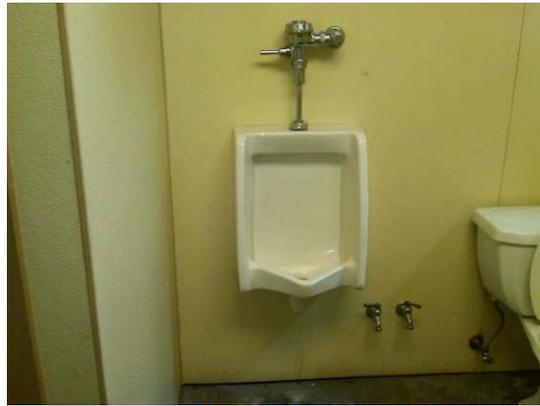
- Water closets are floor mounted; tank type manual flush valve, vitreous china, units appear to be in fair condition.

- Urinals are wall mounted vitreous china, with manual flush valves, units appear newer and in good condition.
- Lavatories are recess count mounted vitreous china and stainless steel. Faucets are a combination of single lever handle and two lever handle type, units appear to be in good condition.

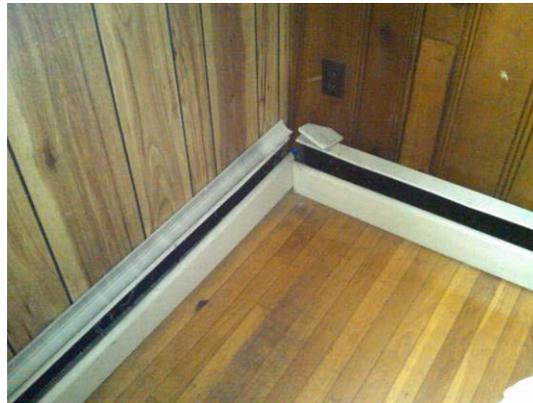
1. The existing building is heated by a single hot water boiler. The boiler is a Weil McLain with an oil fired burner. This boiler appears to be older and in fair condition the burner unit appears to have been replaced at some point looks to be approximately 7-10 years old and in good condition. The pump also appears newer and in good condition. The boiler itself has however reached its life expectancy.
2. The present Heating and Ventilating systems consist of finned tube radiation, with exposed fin tube in the apparatus bays. Ventilation is provided via natural ventilation by means of operable windows. The mechanical equipment is located primarily on exterior walls and in various indoor mechanical spaces within the building.

In general, the systems vary in age from original to the building, to as recent as 5-10 years old. Some equipment such as the existing boiler have reached their life expectancy and should be replaced in order to improve the reliability, efficiency and to cut down on the operational and maintenance costs associated with the heating system.

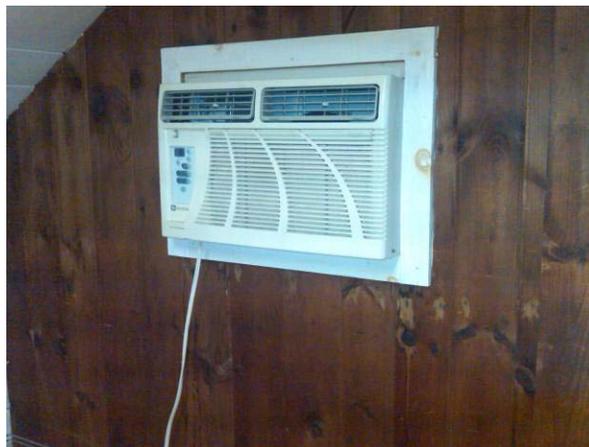
3. The existing temperature controls in the facility is via electric thermostats.
4. A number of thru the wall/window AC units exist to provide air conditioning throughout the building with the exception of the apparatus bay.

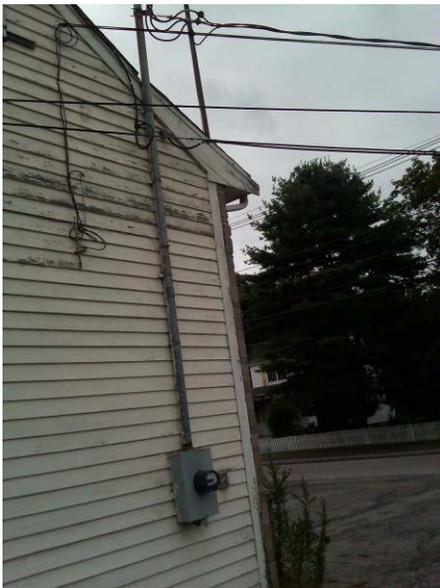
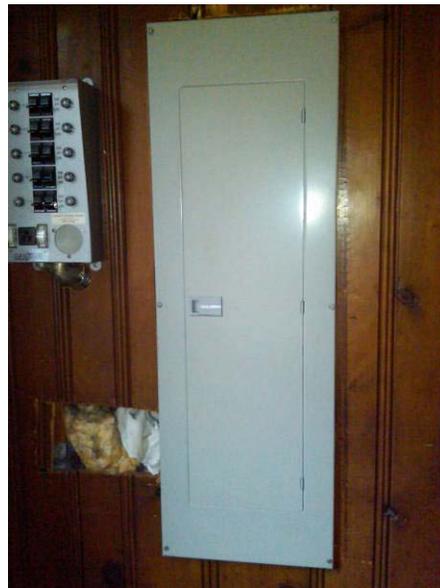
1. The building is served by a single electrical service rated 200 amperes, 120/240volts, single phase, 3-wire and is located in the first floor ready room. The service equipment consists of utility company pole mounted transformer, an overhead feed to a service drop down to building exterior mounted utility meter. The main distribution service equipment is new manufactured by Challenger and in very good condition.

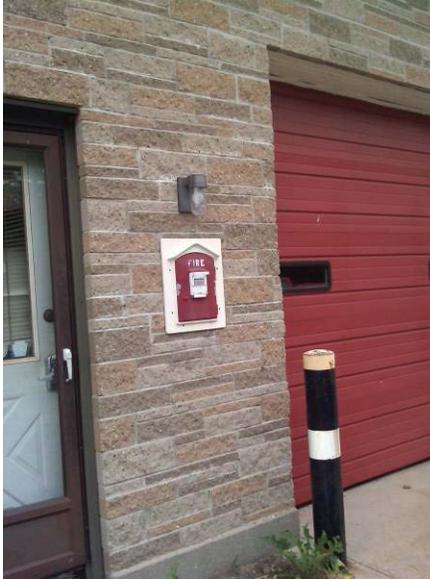
3. The fire alarm system consists of heat detectors installed through most of the facility. It was noted by operations personnel during the walk-thru that the system had been problem free.

4. Site lighting is accomplished via building mounted wall packs these fixtures appear older and in fair/poor condition and should be replaced.
5. There is no on site emergency standby generator.
6. There is no Life safety emergency lighting is provided at this facility.
7. There is no exit lighting is provided at this facility.
8. There is no security system provided at this facility.

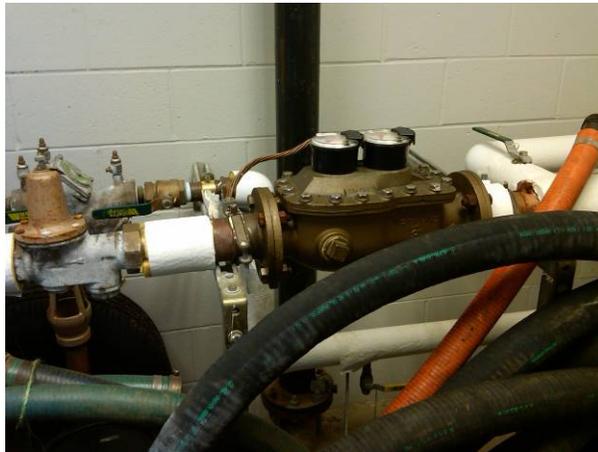
- a. Existing Domestic Water Service: The existing building is currently served by a 2" inch domestic water service located within the water service room. The domestic water service equipment includes a water meter and isolation valves. This water service currently serves all of the Facilities domestic water needs. The water distribution system is original to the building.

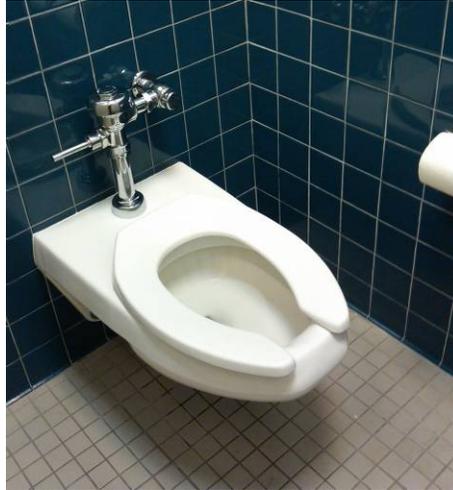
- Water closets are wall mounted; manual flush valve, vitreous china, units appear in very good condition.

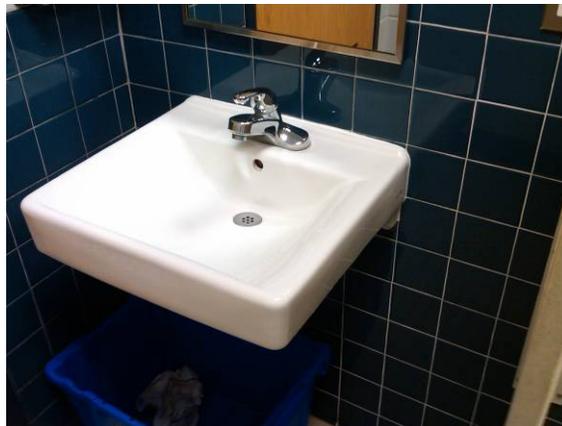
- Urinals are wall mounted vitreous china; with manual flush valves, units appear in very good condition.
- Lavatories are wall hung vitreous china. Faucets are single lever manual handle type; units appear in very good condition.

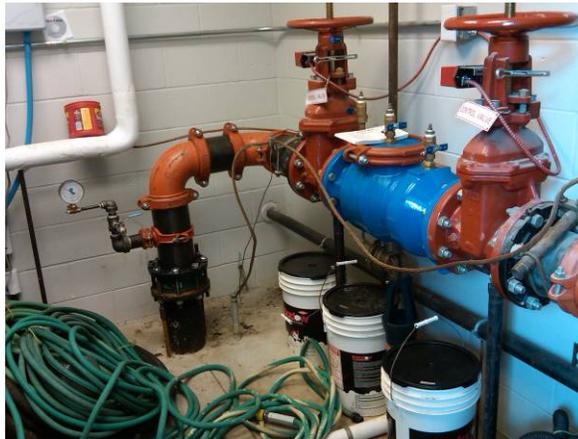
1. There is a complete fire protection (sprinklers) system in the facility. Coverage appears to cover all areas of the buildings. The system is complete with all back flow prevention devices and fire alarm system monitoring. The service enters the building in the Water service entrance room in the front of the building with a 6" service line.

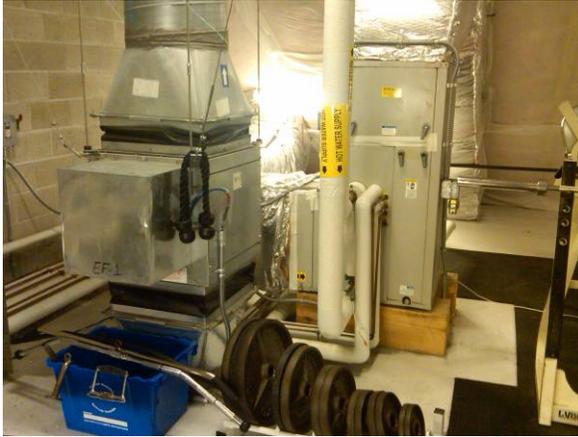
1. The existing building is heated and cooled via multiple attic mounted Air Handler units. These units are manufactured by Aaon are original to the building (6-7 years old) and were noted as operating problem free. These units include hot water and cooling coils for heating and cooling as well as a fresh air component. Hot water for the heating system is provided by a gas fired Fulton Boiler also original to the facility and located in the second floor Mechanical room this unit is in very good condition. Cooling is provided from exterior ground mounted individual condenser units located at the rear of the building.

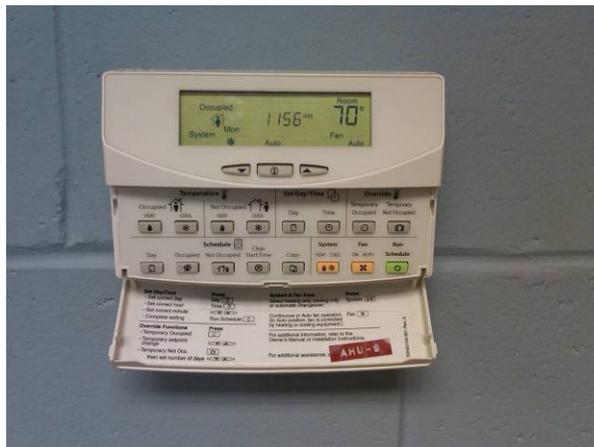
2. The present Heating Ventilating and Air Conditioning systems consist of a ducted air system throughout the building. Selected areas such as the sally port and the apparatus bays are heated by infrared tube heaters. The air-handling units have hot water heating coils, cooling coils, filter sections and exhaust fans.
3. The existing temperature controls in the facility are via electronic thermostats controlling individual air handling units these were noted as operating without issue.

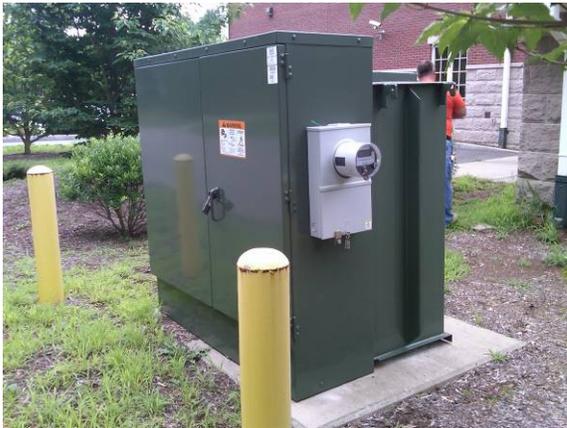
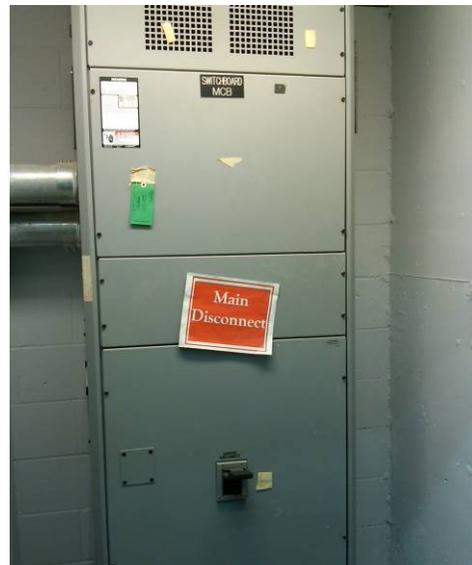
1. The building is served by a single electrical service rated 1200 amperes, 208Y/120volts, 3-phase, 4-wire and is located in the main electric room. The service equipment consists of a utility company pad mounted transformer with pad mounted utility metering equipment an underground feed to a 1200amp main disconnect circuit breaker switchboard with distribution section located in the main electric room. The predominance of the main distribution equipment service equipment is newer (2005) and in very good condition.

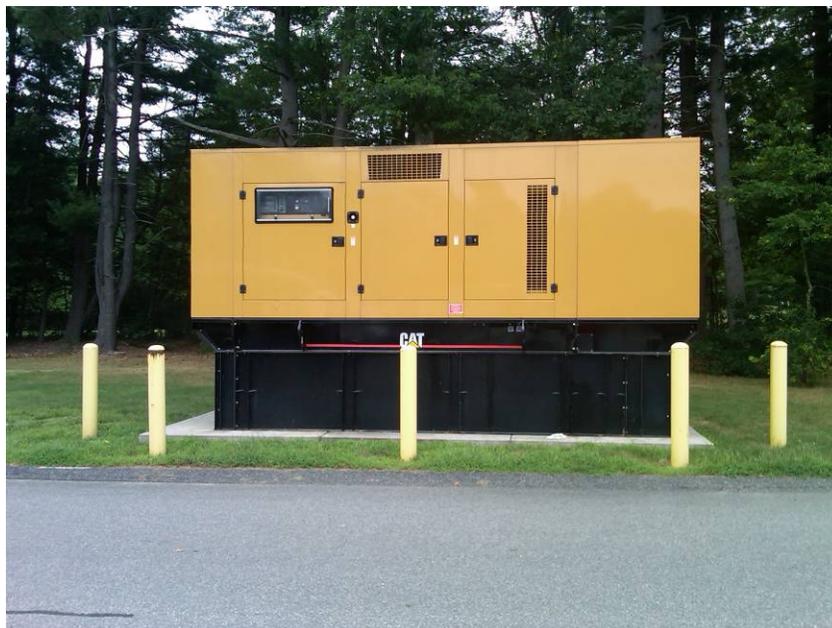
5. Site lighting is accomplished via building mounted wall packs, and LED type sconce type lights and a number of pole mounted fixtures all appear to be in very good condition.
6. There is currently an oil fired Caterpillar emergency standby generator. This unit appears to be in very good condition. It was noted by operations personal as functioning without any issues and that it offers 100% backup of the facility.

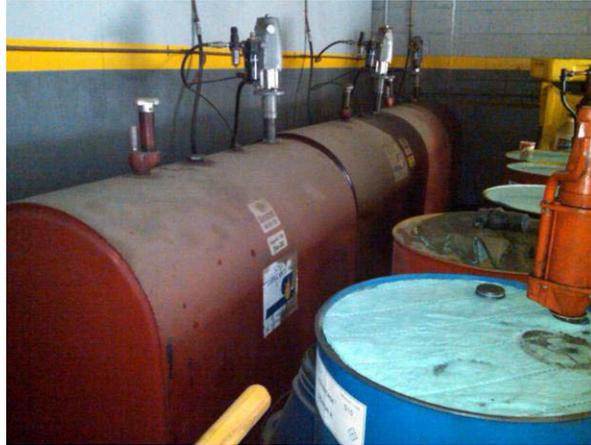
- a. There are 3-330gallon above ground as well as a number of 55 gallon drums on site to house automobile oil for related to the trucks.

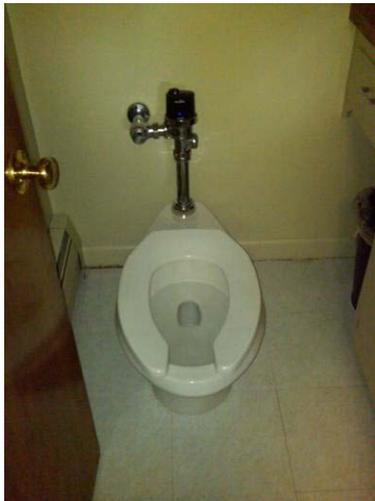
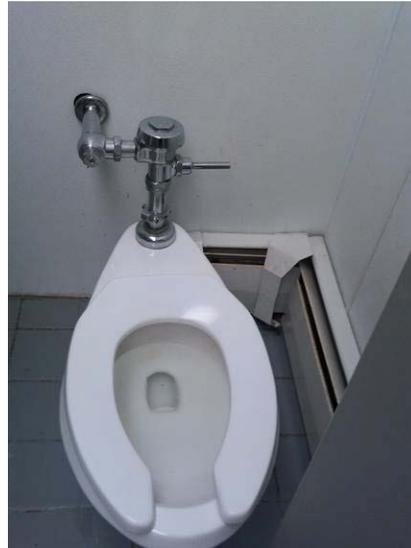
- Water closets are floor mounted; with auto and manual flush valves, vitreous china. Units appear to be in very good condition.

- Urinals are wall mounted vitreous china, waterless units. Units are in very good condition.
- Lavatories are wall hung vitreous china. Faucets are a combination of two lever handle type.
- Janitor's mop sinks are wall mounted basins with 2-faucets and vacuum breakers. These basins are older and in good/fair condition.
- It was noted by operations personnel that the existing plumbing piping system was old and that they experienced leaks on a frequent basis.

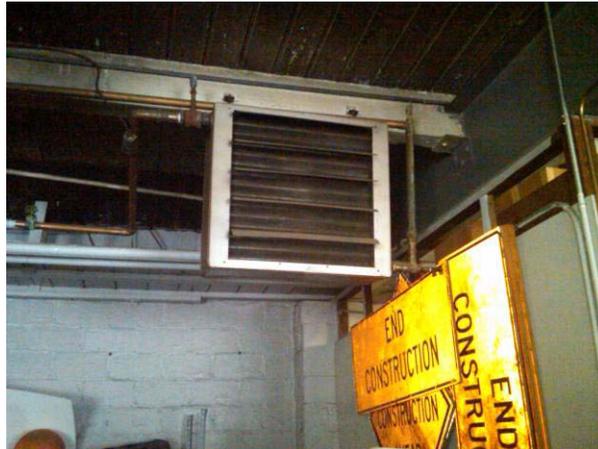
2. The present Heating and Ventilating systems consist of finned tube radiation, hot water unit heaters and exhaust systems. The mechanical equipment is located primarily on exterior walls and in various indoor mechanical spaces within the building.
3. Unit heaters in equipment bays are older and in poor condition. They have begun to fail and repairs are becoming more frequent as they have already exceeded their useful life.

In general, the systems vary in age from original to the building, to as recent as 1-3 years old. Some equipment such as the unit heaters in the equipment bays and the existing boiler have reached their life expectancy and should be replaced in order to improve the reliability, efficiency and to cut down on the operational and maintenance costs associated with the heating system.

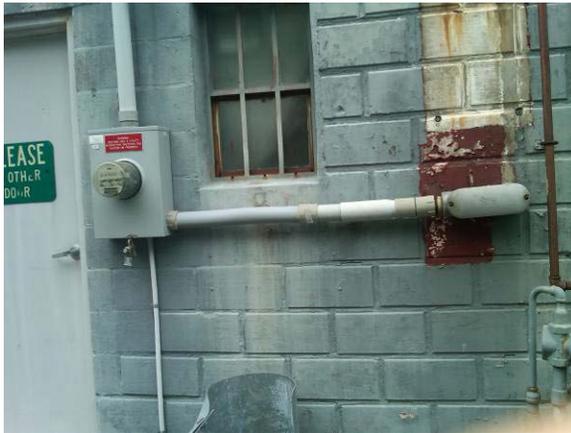
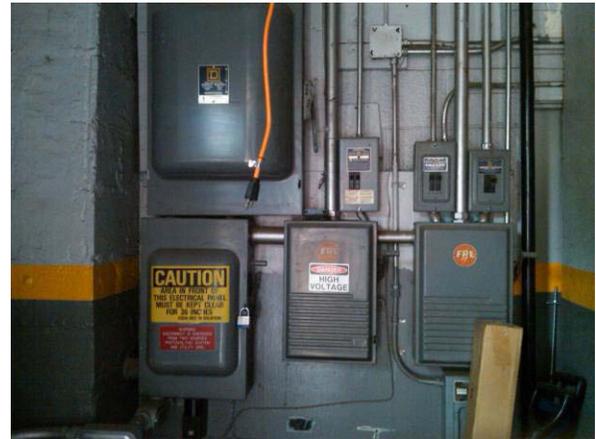
1. The building is served by a single electrical service rated 200 amperes, 120/240volts, single-phase, 3-wire and is located in the corner area of the apparatus bay designated for the electric service. The service equipment consists of a utility company pole mounted transformer, an overhead feed to utility metering equipment a 200amp main disconnect switch and distribution equipment. The predominance of the main distribution service equipment older and in fair condition.

The Electrical systems appear to be in good condition however the older distribution equipment (panelboards) should be replaced with newer equipment with additional breaker spaces to meet any future needs and to alleviate the possibility of overloading individual circuits when new equipment and or devices are added to the existing circuitry. The lighting systems are older and should be replaced with newer more efficient fixtures utilizing the latest lamping and ballasting configurations in order to improve energy efficiency. The addition of automated lighting controls should be implemented in order to meet current energy codes and to save on energy costs. Fire alarm system should be expanded and or upgraded to add detection devices for earlier detection of any problems. Existing exits and emergency lighting units should be replaced to ensure the reliability of these systems in case of an emergency. The existing emergency generator should be reviewed to determine the cause of the previous problems to determine if the unit can be repaired and or requires replacement.

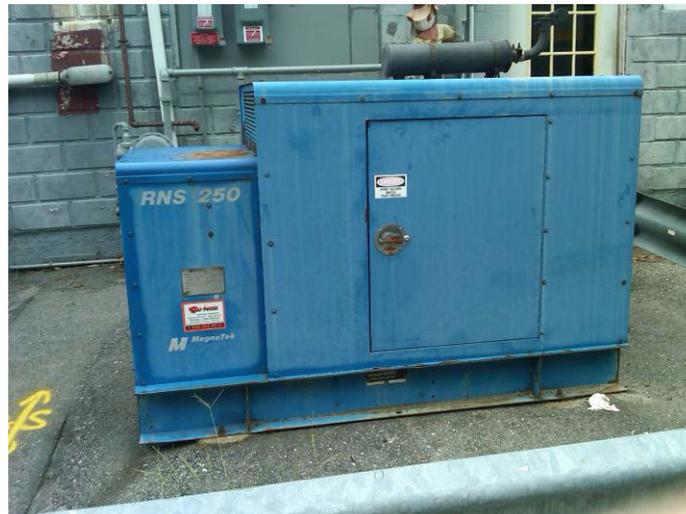
6. Site lighting is accomplished via building mounted LED wall packs these fixture appear newer and in very good condition.
7. There is an exterior emergency standby generator located at the rear of the facility. This unit is natural gas fired rated 20KW and manufactured by Magnetek. It was noted by operations personnel that this unit has experienced problems in the past. The unit is older and in fair condition. Transfer is a manual operation and can power the entire facility with the manual shutoff of select loads.

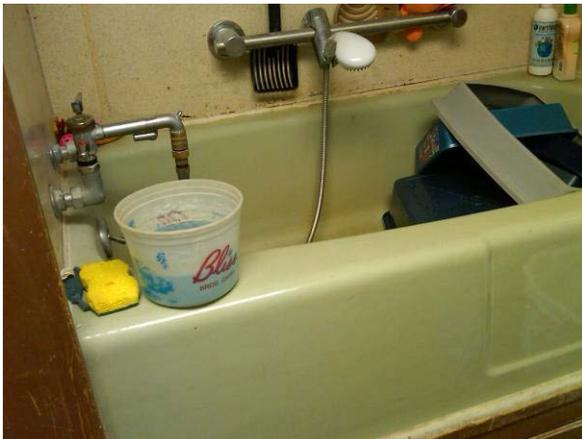
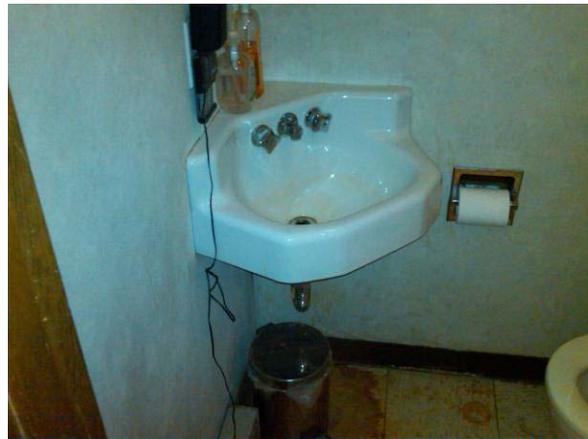
- Water closets are floor mounted tank type, vitreous china. Units appear to be in good condition.
- Lavatories are wall hung vitreous china. Faucets are of the two lever handle type. Unit is older and in fair/poor condition.

Plumbing systems all appear older and in fair condition. Replacement of existing older plumbing fixtures should be enacted to replace the older units.

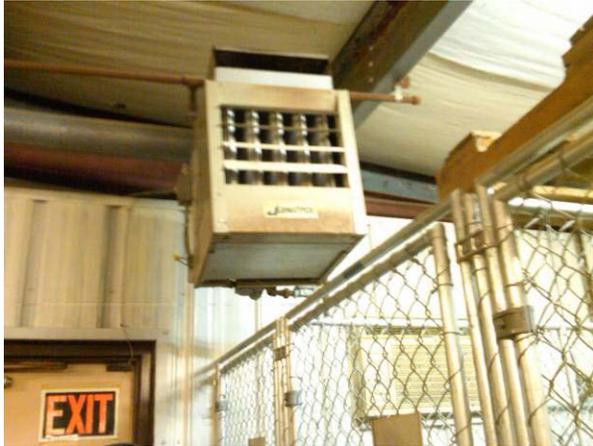
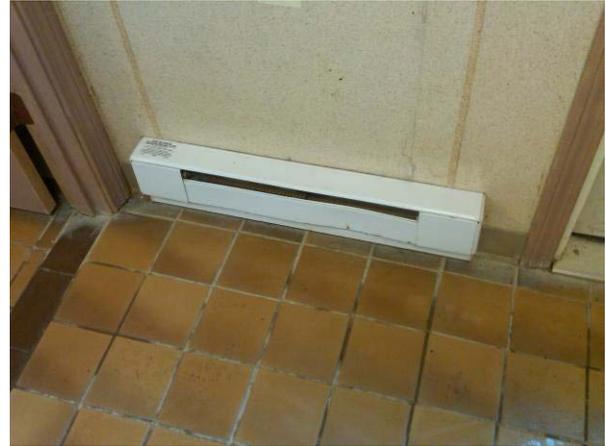
1. The existing building is heated by gas fired unit heaters and electric baseboard radiation. These units are in good condition.

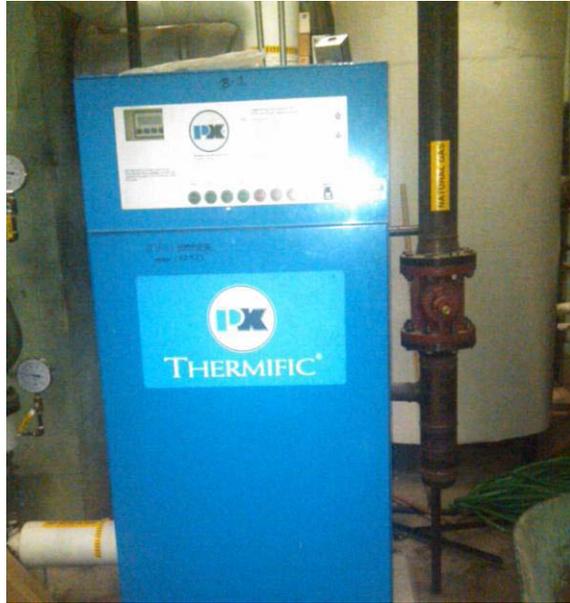
1. The existing building is heated by two hot water boilers. The two boilers are both manufactured by PK one being a Thermific installed in 2003 and the second being a Modufire installed in 2008 both with burners currently operating on Natural gas. These two boilers are both fairly new and operating without any noted problems. Both units are rated 2000 MBH and are in very good condition.

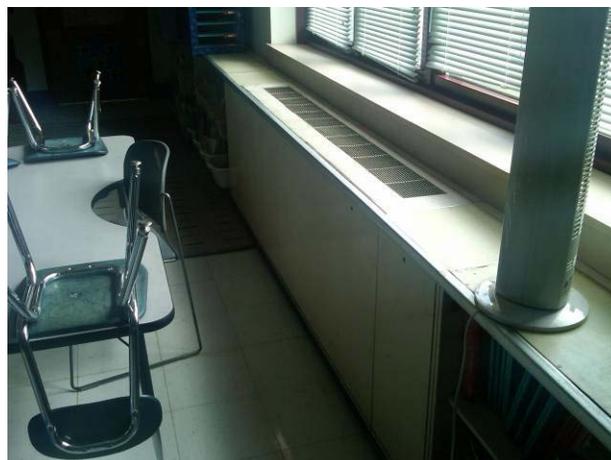
3. Unit Ventilators in classrooms are a mix with approximately 50% of the units having been replaced within the last 3-5 years and the remaining units being approximately 30+/- years old manufactured by Trane. The older units have exceeded the life expectancy and repairs are becoming more frequent. Although they have been able to obtain parts for repairs when needed, obtaining these parts will become more of an issue as more units fail and require replacement parts, these older units should be replaced.

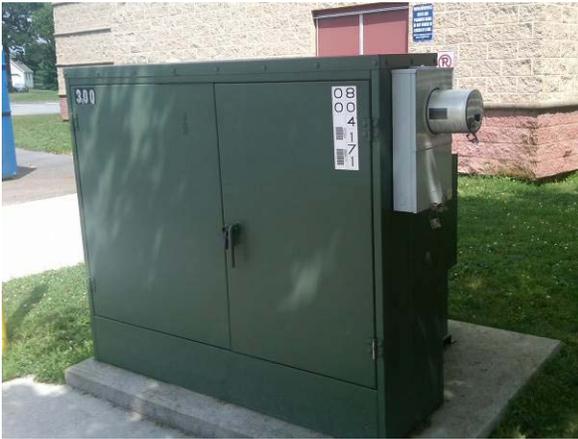
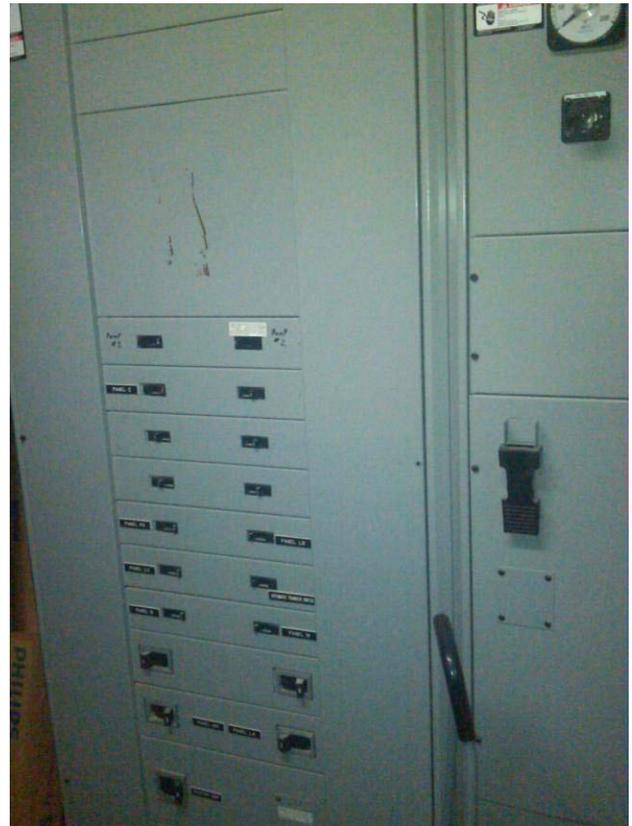
1. The building is served by a single electrical service rated 1200 amperes, 208Y/120volts, 3-phase, 4-wire and is located in the main electric room. The service equipment consists of utility company pad mounted transformer believed to be a 300 KVA unit, with pad mounted utility metering equipment an underground feed to a 1200amp switchboard with main switch and distribution section located in the main electric room. The predominance of the main distribution equipment service equipment is new (2001) and in very good condition.

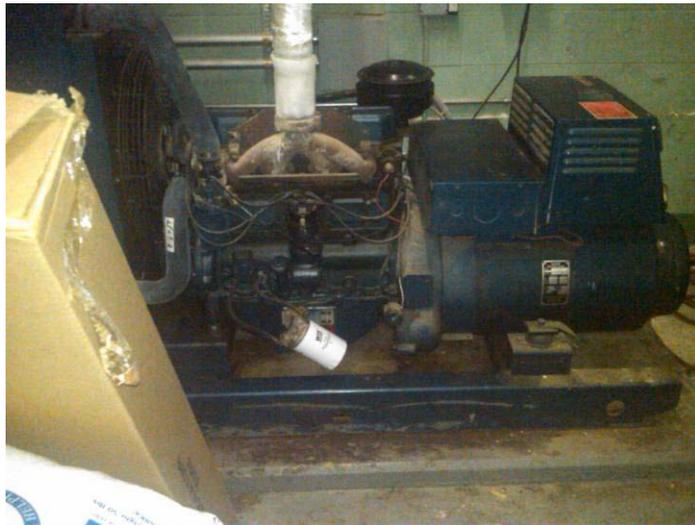
4. The fire alarm system is a Simplex 4100 addressable system. There are manual fire alarm pull stations, horn strobes located throughout the building. Heat and smoke detectors are present in select areas. The system appears to be newer in very good condition and it was noted by school personnel during the walk-thru that the system had been problem free.
5. Site lighting is accomplished via building mounted wall packs and a number of pole mounted flood lights both appear to be in good condition.
6. There is currently a 25KW gas fired Kohler emergency standby generator. This unit appears quite old. It was noted however as functioning without any issues. Whereas it does serve the life safety needs of the school including emergency lighting it should be completely checked to ensure its reliability and replacement should be considered.

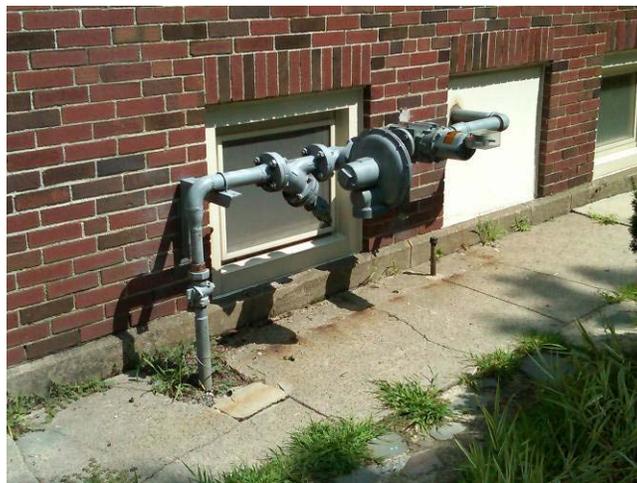
- a. Existing Natural Gas Service: There is currently an existing natural gas service to the building serving the boiler, hot water heaters and select kitchen equipment. This service enters the front of the building near the main entry.

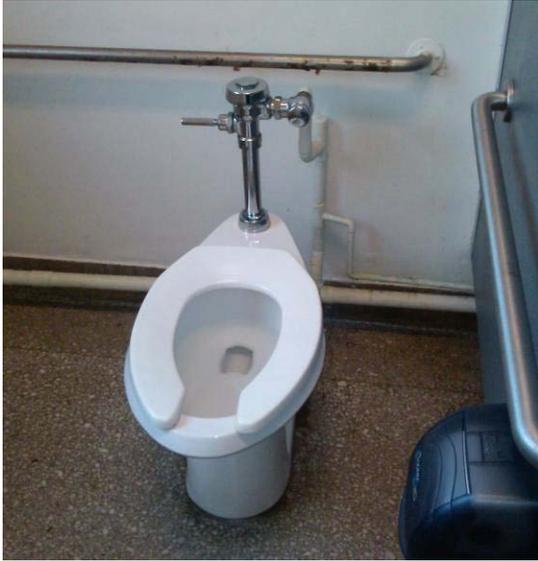
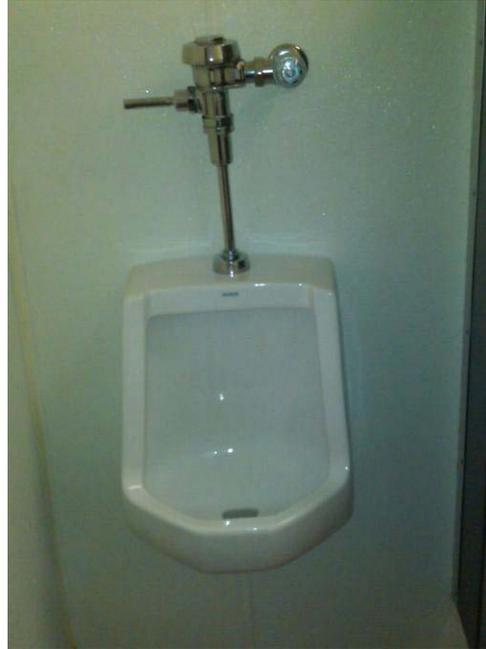
- Water closets are floor mounted; manual flush valve, vitreous china, units appear in good condition.

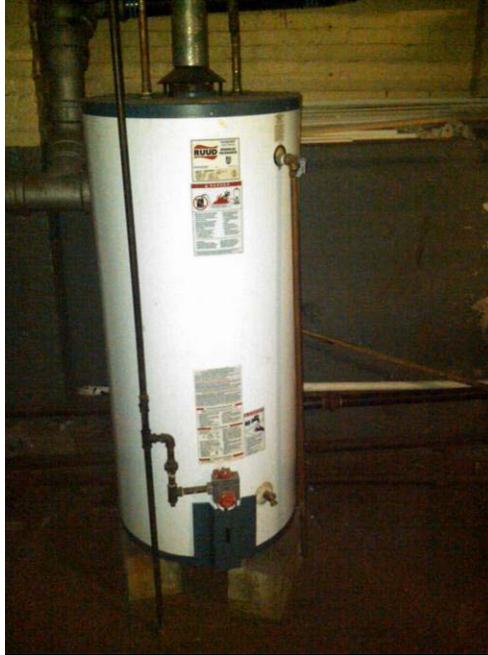
1. Existing Domestic Hot Water System: The Schools domestic hot water is generated by a 175 gallon tank type gas fired hot water heater. The unit appears in good condition.

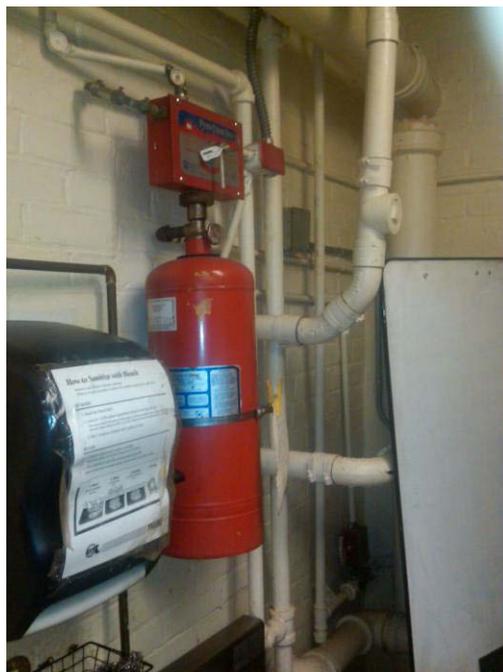
1. There is no fire protection (sprinklers) system in the facility.
2. Kitchen hood is provided with an ansul chemical fire suppression system.

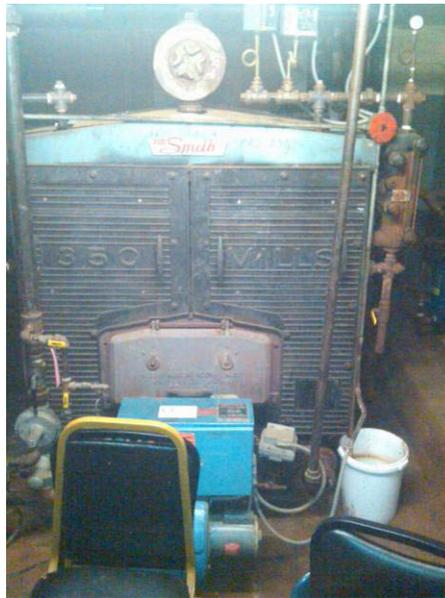
1. The existing building is heated by a single steam boiler. The boiler is manufactured by H.B. Smith appears to be 35 plus years old and rated 1700 MBH. The boiler's burner is currently operating on Natural gas as the fuel source. This boiler is old and should be replaced as its life expectancy has already been exceeded.

In general, the systems vary in age from original to the building, to as recent as 2-3 years old. Some equipment the existing boiler are 30+ years old and have exceeded their life expectancy and should be replaced in order to improve the reliability, efficiency and to cut down on the operational and maintenance costs associated with the heating system. Steam traps should be examined to determine if repair or replacement is required to ensure the efficiency of the heating system.

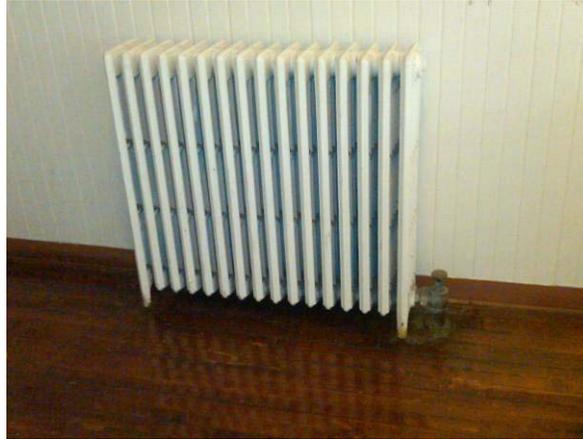
3. Radiation units throughout appear to be original and in good condition the condition of the steam traps was indeterminable but these should be checked and replaced if required.
