Capital Improvement Study

Town of Seekonk

Massachusetts

Drummey Rosane Anderson, Inc.

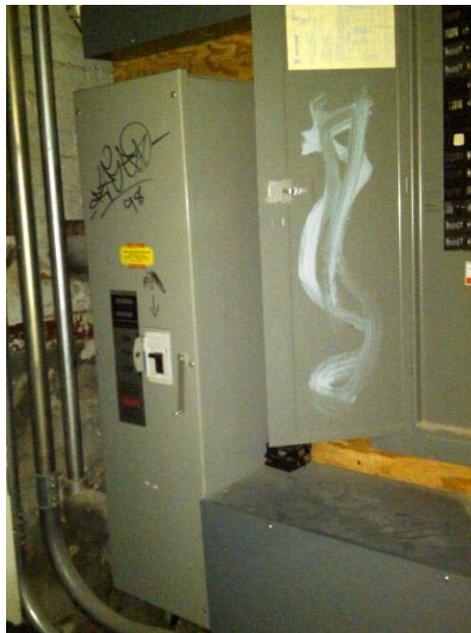
1. The building is served by a single electrical service which is believed to be rated 400 amperes, 240/120volts, single-phase, 3-wire. The service equipment consists of utility company pole mounted transformers, an overhead feed and service drop to exterior building mounted utility metering a 400amp interior main service disconnect circuit breaker and distribution panelboard. The equipment is located in the basement electrical closet was installed in 1992, is manufactured by Cutlet Hammer and is in very good condition.

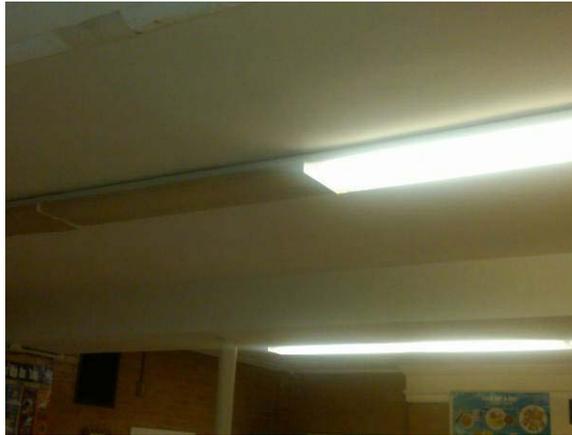
3. The lighting throughout the facility consists primarily of surface and pendent mounted 1x4 lensed wraparound fluorescent fixtures and recess mounted 2x4 lensed fluorescent fixtures. The lighting throughout the facility is in good condition but does not include any motion sensor control. The light levels appear to be within recommended levels.

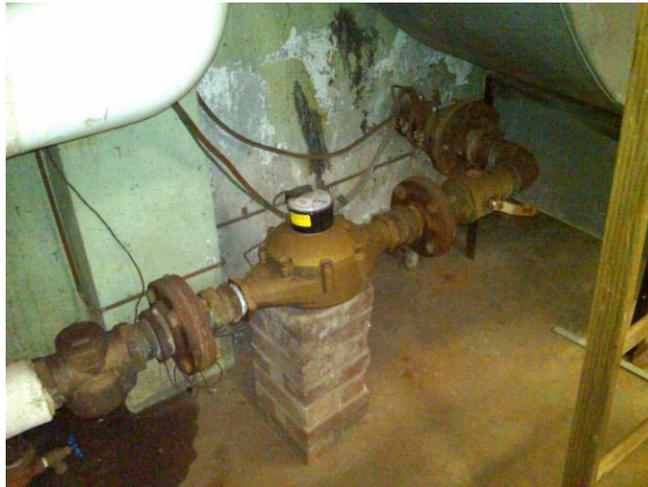
- a. Existing Domestic Water Service: The existing building is currently served by a 4" inch domestic water service located within the boiler/mechanical room. The domestic water service equipment includes a water meter and isolation valves. This water service currently serves all of the Schools domestic water needs. The water distribution system is original to the building and each subsequent addition/renovation.

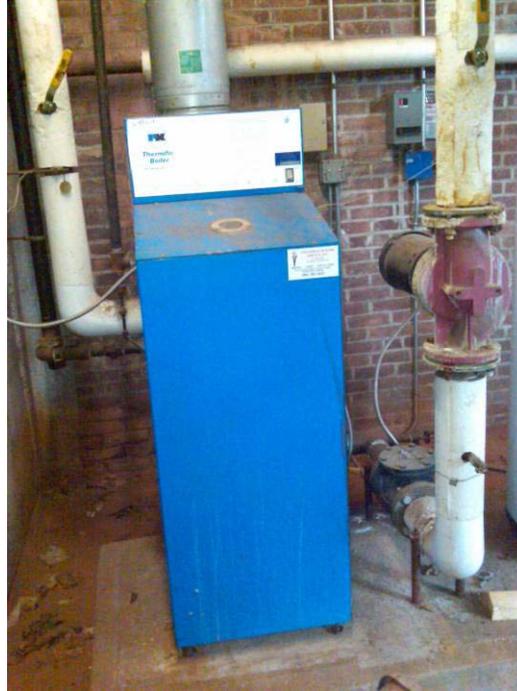
1. Existing Domestic Hot Water System: The Schools domestic hot water is generated by a 75 gallon tank type gas fired hot water heater and a P.K. Thermific boiler both units appear newer and in very good condition.

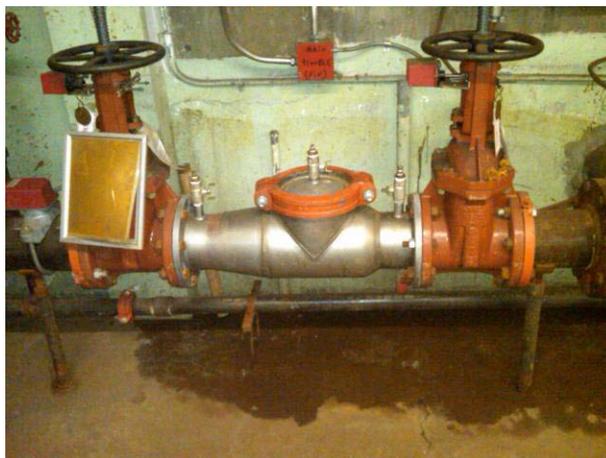
1. There is a complete fire protection (sprinklers) system in the facility. Coverage appears to cover all areas of the buildings. The system is complete with all back flow prevention devices and fire alarm system monitoring. The service enters the building in the boiler room with an 8" service.

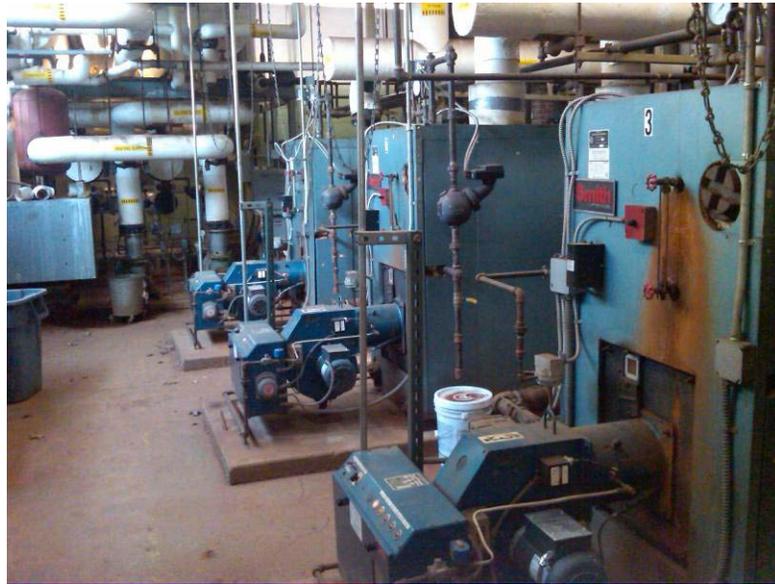
1. The existing building is heated by three steam boilers. The three steam boilers are manufactured by Smith installed in 1997 and steam to hot water heat exchangers are utilized to provide hot water to the 1970 and 1997 additions. All three have burners currently operating on Natural gas. These three boilers are fairly new 13 years old. The units are rated 3563 MBH each.

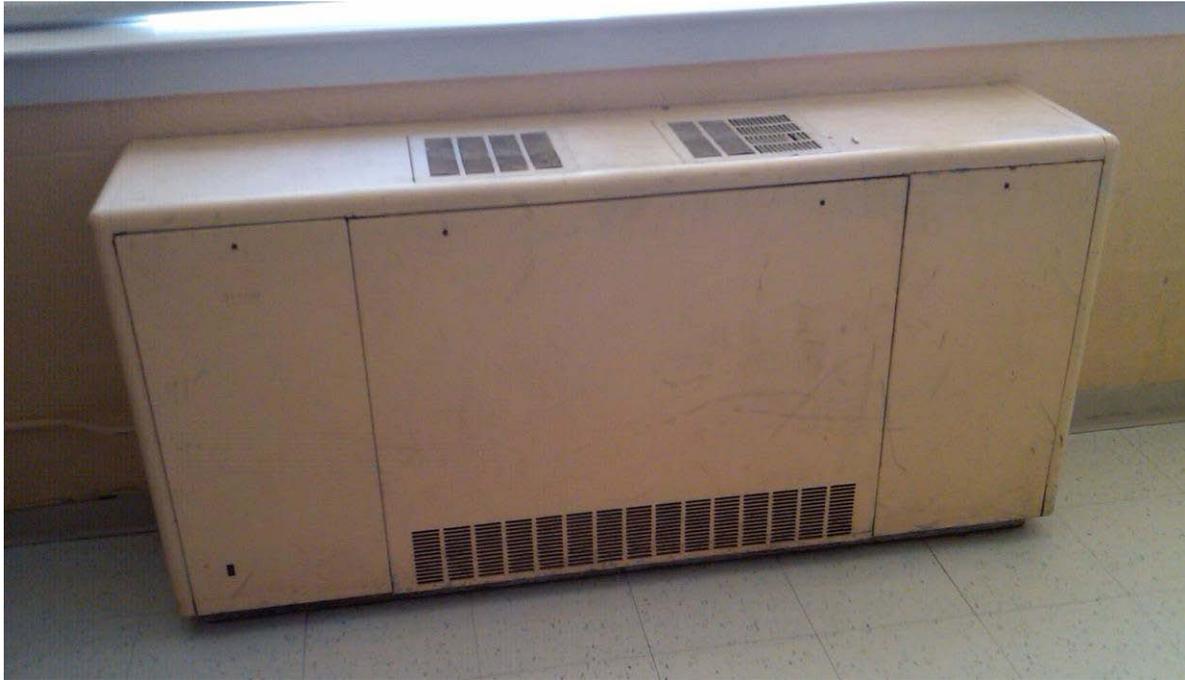
3. Unit Ventilators in classrooms are a mix with approximately 50% of the units having been replaced within the last 10+/- years and the remaining units being approximately 30+/- years old manufactured by Trane. The older units have exceeded the life expectancy and repairs are becoming more frequent. Although they have been able to obtain parts for repairs when needed, obtaining these parts will become more of an issue as more units fail and require replacement parts, these older units should be replaced prior to permanent failures.

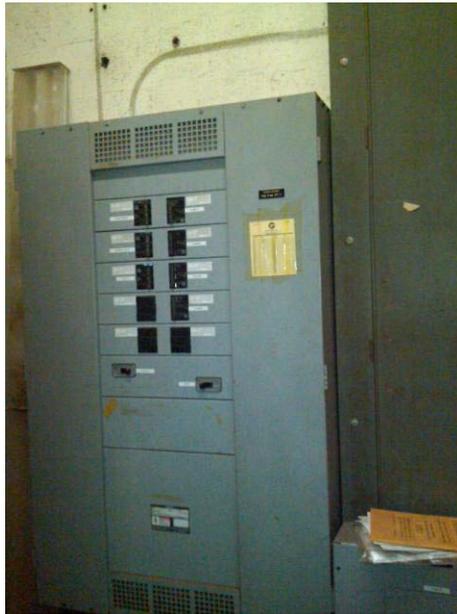
1. The building is served by a single electrical service rated 2000 amperes, 208Y/120volts, 3-phase, 4-wire and is located in the main electric room. The service equipment consists of utility company pad mounted transformer, utility metering equipment an underground feed to a 2000amp switchboard with main switch and distribution section located in the main electric room. The predominance of the main distribution equipment service equipment is newer (1997) and in very good condition.

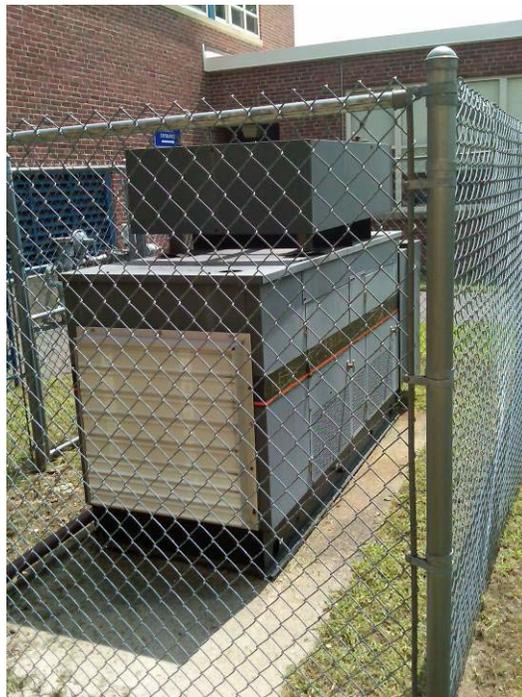
5. Site lighting is accomplished via building mounted wall packs, floodlights and a number of pole mounted HID shoebox fixtures both appear to be in good condition.
6. There is currently a gas fired Olympian emergency standby generator. This unit appears to be in very good condition and is believed to have been installed at the time of the 1997 addition. It was noted by operations personal as functioning without any issues.

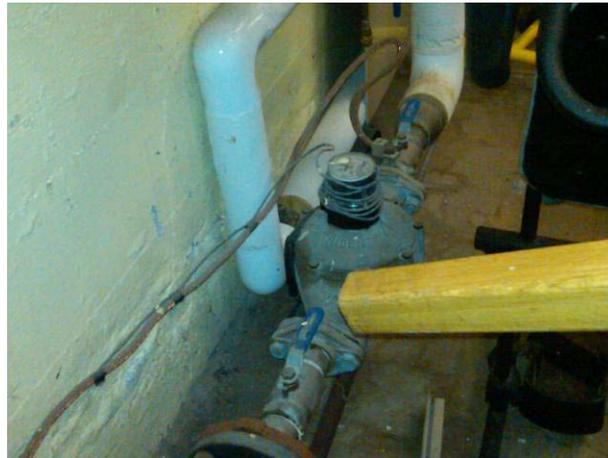
- a. Existing Domestic Water Service: The existing building is currently served by 4" domestic water service located within the basement storage area adjacent to the sprinkler service. The domestic water service equipment includes a water meter and isolation valves. This water service currently serves all of the Schools domestic water needs. The water distribution system is original to the building and each subsequent addition/renovation.

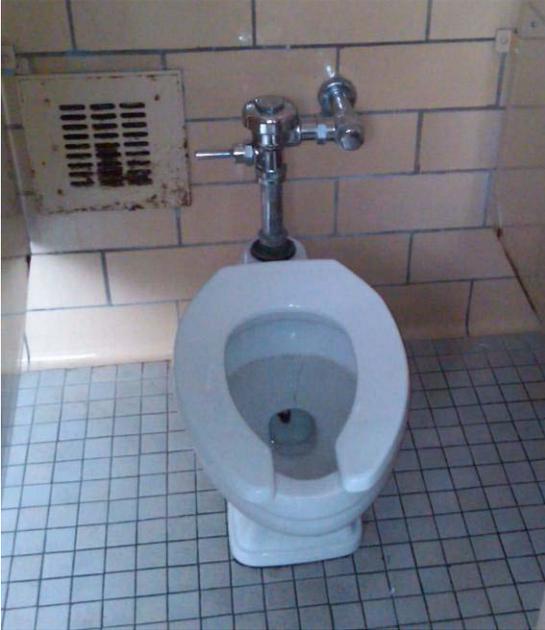
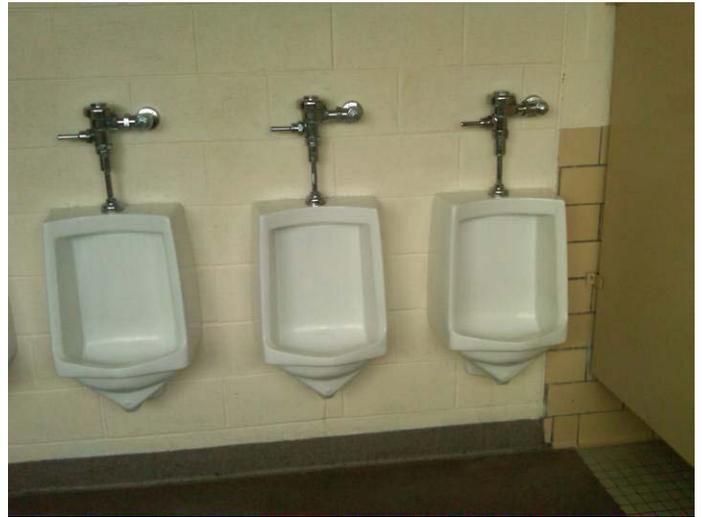
- Water closets are floor mounted; manual flush valve, vitreous china, units appear in very good condition.

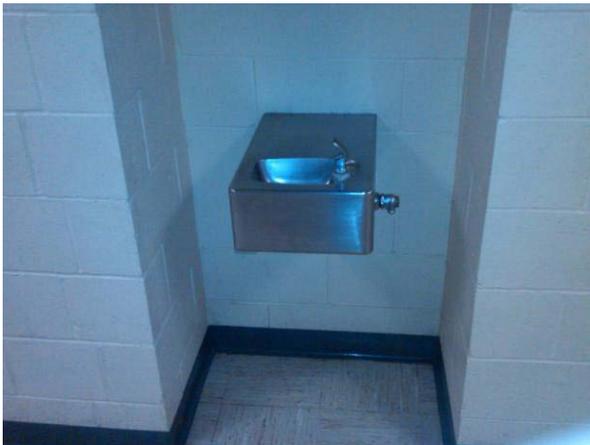
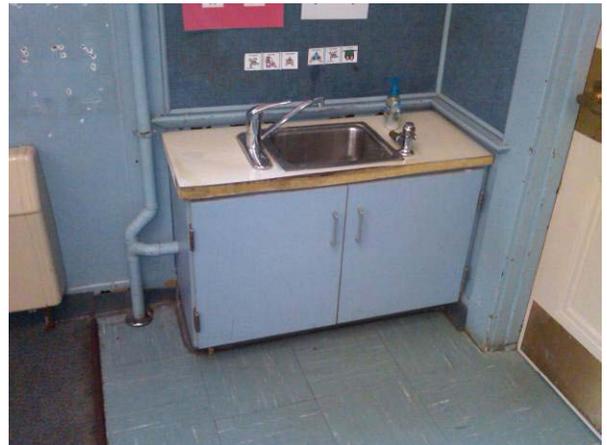
- Urinals are wall mounted vitreous china; with manual flush valves, units appear in very good condition.
- Lavatories are wall hung vitreous china. Faucets are single lever handle type, units appear in good condition.
- Drinking fountains are surface mounted stainless steel. Most appear to be ADA compliant, and are in very good condition.

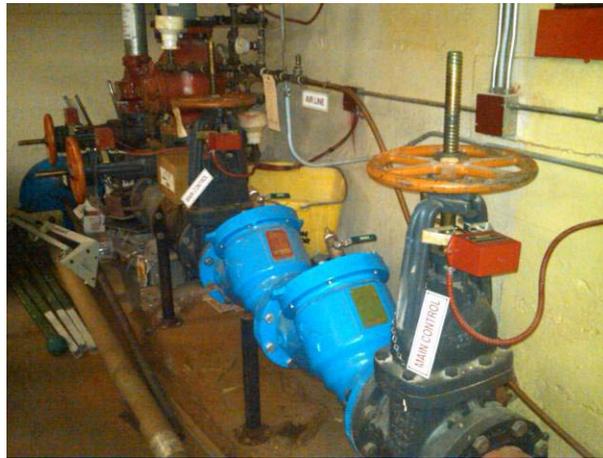
1. There is a complete fire protection (sprinklers) system in the facility. Coverage appears to cover all areas of the buildings. The system is complete with an 8" incoming line located in the basement storage area, complete with back flow prevention devices and fire alarm system monitoring.

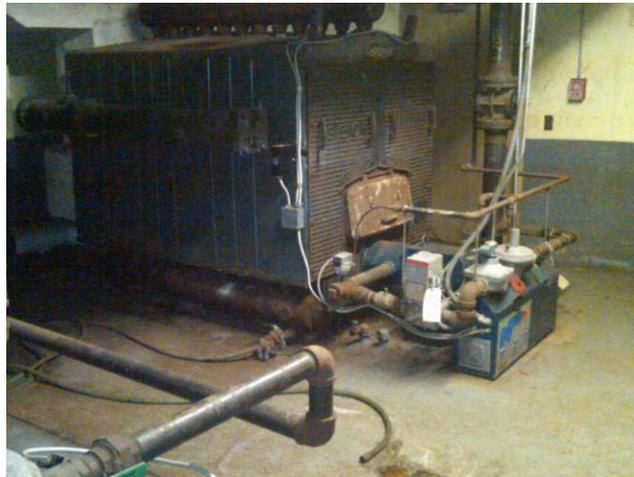
1. The existing building is heated by two hot water boilers. The two boilers are both manufactured by H.B. Smith one being newer approximately 25 years old and rated

2146 MBH and the second being older (40+/- years old) with an indeterminable output but believed to be in the same 200MBH range. Both boilers have their burners operating on Natural gas as the fuel source. These two boilers are both old one having already exceeded its life expectancy and the second currently at its life expectancy. We were informed that ongoing repairs have been necessary on both. These units are in fair and poor condition and should be replaced.

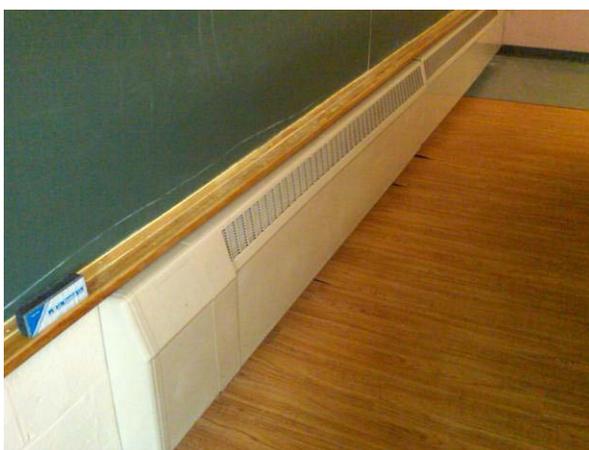
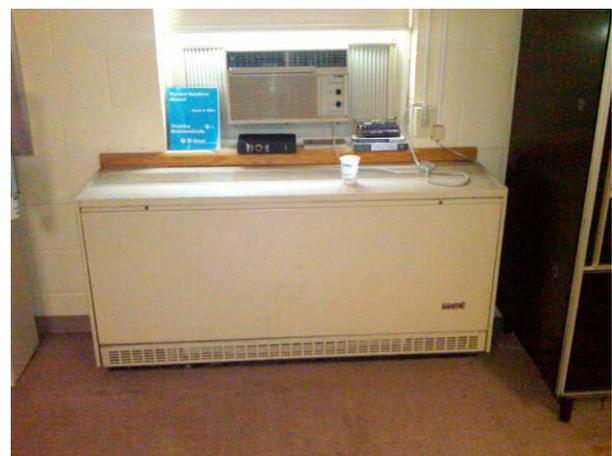
2. The present Heating and Ventilating systems consist of finned tube radiation, unit ventilators in the classrooms and exhaust systems. Areas such as the gymnasium and cafeteria are also served by unit ventilators, fin tube radiation and exhaust systems. The mechanical equipment is located primarily on exterior walls and in various indoor mechanical spaces within the building. The air-handling units have hot water heating coils, filter sections and exhaust fans.
3. Unit Ventilators in classrooms appear to be approximately 15-20 years old manufactured by MSI. These units appear to be in good condition and have been operating without any noted issues according to operations personal.

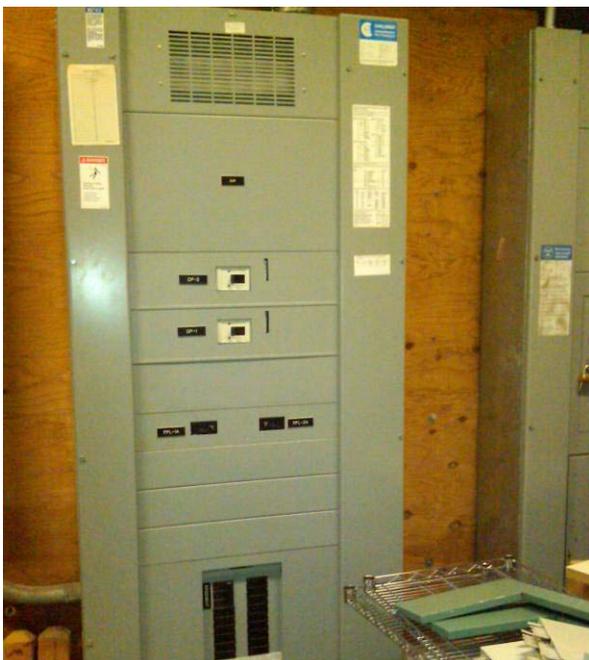
1. The building is served by a single electrical service rated 800 amperes, 208Y/120volts, 3-phase, 4-wire. The service equipment consists of utility company pad mounted transformer believed to be a 150 KVA unit, an underground feed to an 800amp Challenger main distribution panel with utility metering equipment located in the basement main electric room. The predominance of the main distribution equipment service equipment is newer (1992) and in very good condition.

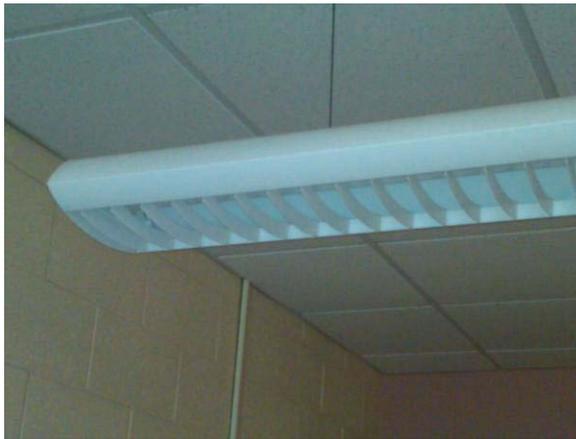
3. The lighting throughout the facility consists primarily of recess mounted 2x4 lensed fluorescent fixtures. In the classrooms and other academic areas pendent mounted direct/indirect fluorescent fixtures are utilized. The lighting throughout the facility is newer and in good condition and includes motion sensor control. The light levels appear to be within recommended levels.

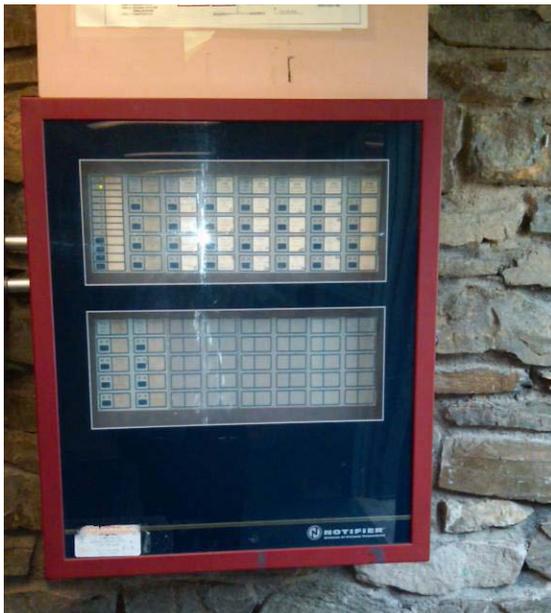
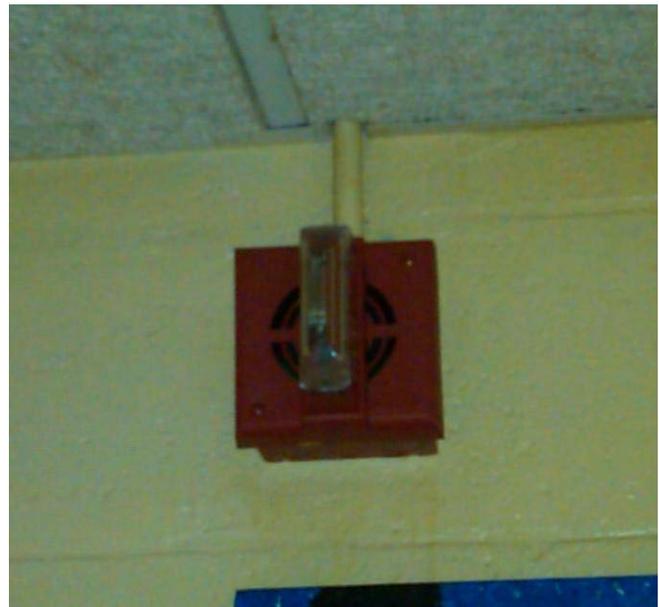
4. The fire alarm system is a Notifier zoned system. There are manual fire alarm pull stations, horn strobes located throughout the building. Heat and smoke detectors are present in select areas including smoke detectors in all corridors. The system appears to be 15+/- years old and in good condition and it was noted by school personnel during the walk-thru that the system had been problem free. Coverage and compliance with current codes appears to be sufficient.

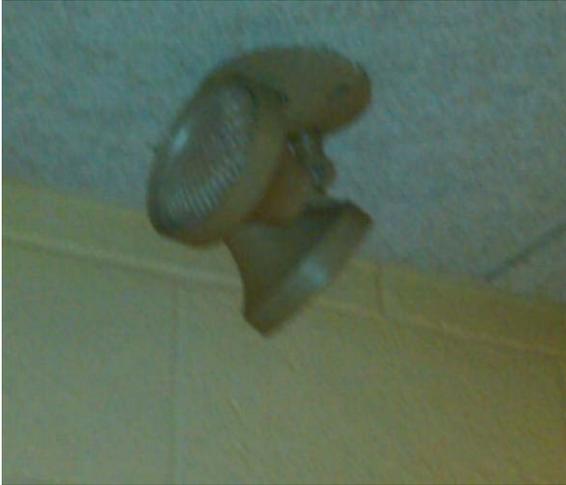
5. Site lighting is accomplished via building mounted wall packs and pole mounted shoebox HID type fixtures, all fixtures appear to be in good condition.
6. There is currently no emergency standby generator to serve the facility.
7. Life safety emergency lighting is provided remote light heads wired to multiple central battery units throughout the facility. These units and central battery units appear in good condition

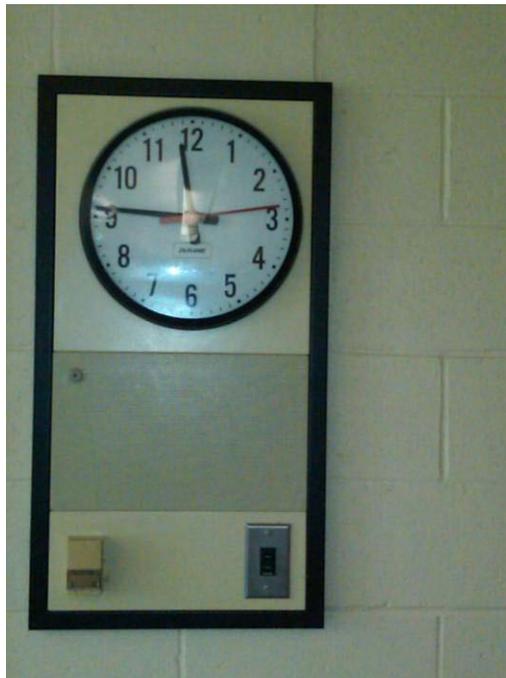
8. Exit lighting is installed throughout, is wired to central battery units as their emergency source and are in good condition.
9. The existing clock system was noted as non-functioning with clocks within the school now operating on batteries.

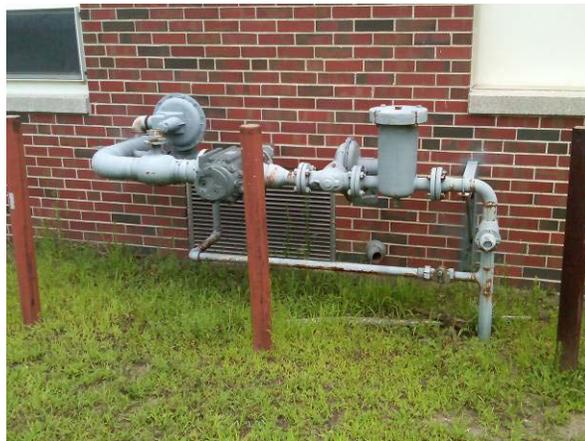
- a. Existing Natural Gas Service: There is currently an existing natural gas service to the building serving the boilers, hot water heaters and select kitchen equipment. This service enters the rear of the building at the boiler room.

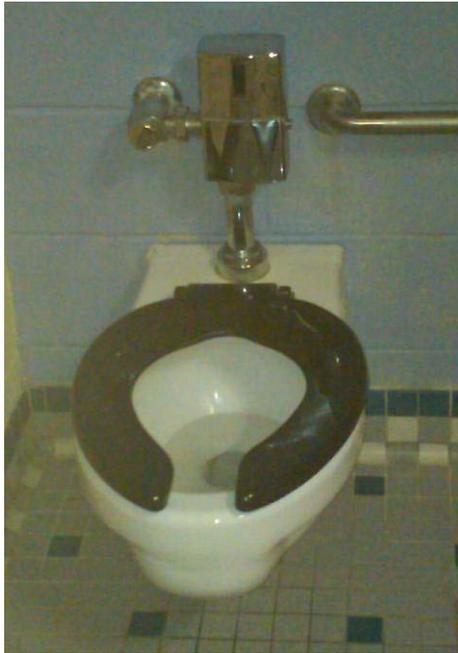
- Water closets are wall mounted; auto flush valve, vitreous china, units appear in very good condition.

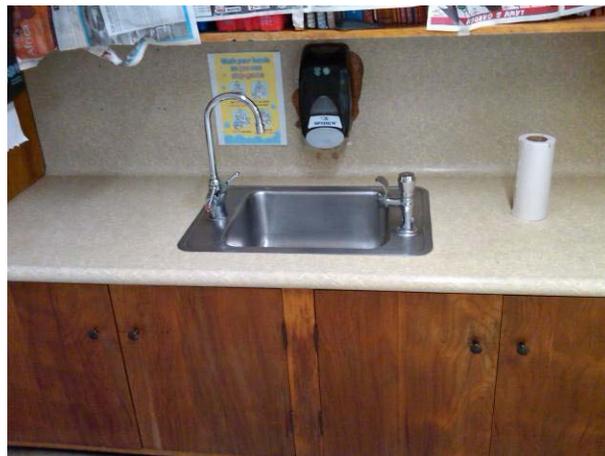
- Urinals are wall mounted vitreous china, with auto flush valve; units appear in very good condition.
- Lavatories are wall hung vitreous china. Faucets are single lever handle auto type, units appear in very good/good condition.
- Drinking fountains are surface mounted stainless steel dual level units a few older Vitreous china recess mounted unit do exist. Most appear to be ADA compliant, and are in very good condition.
- Typical classroom sinks are counter top, stainless steel units with dual lever gooseneck faucets. Most appear to not be ADA compliant.

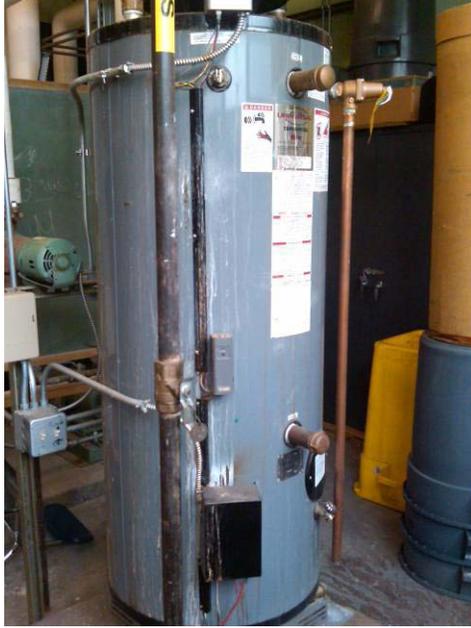
1. Existing Domestic Hot Water System: The Schools domestic hot water is generated by a 85 gallon tank type gas fired hot water heater. The unit is approximately 5-6 years old and appears in very good condition.

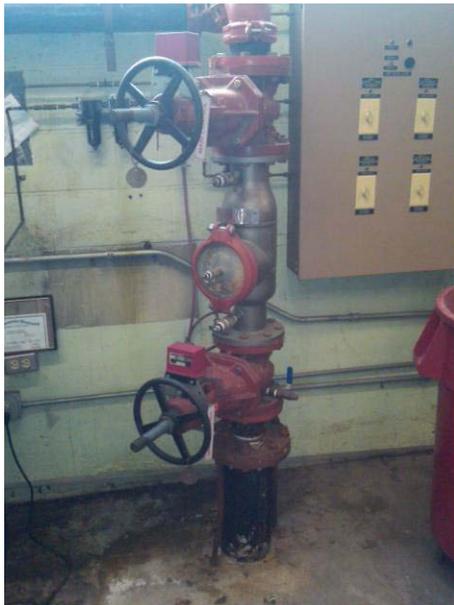
1. There is a complete fire protection (sprinklers) system in the facility. Coverage appears to cover all areas of the buildings. The system is complete with an 8" incoming line, all back flow prevention devices and fire alarm system monitoring. The service enters in the boiler/mechanical room.

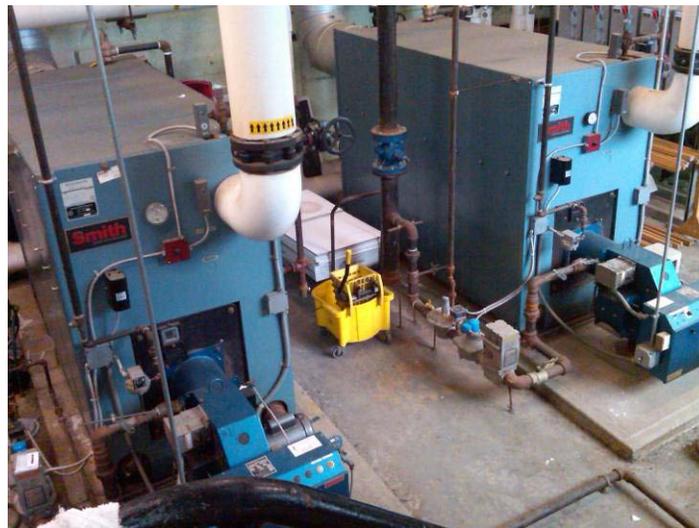
1. The existing building is heated by two hot water boilers. The two boilers are both manufactured by Smith were installed during the 1997 renovation and are in very good condition. Both boilers have their burners operating on Natural gas. These two boilers are both fairly new and operating without any noted problems. Both units are rated 2403 MBH and are in very good condition.

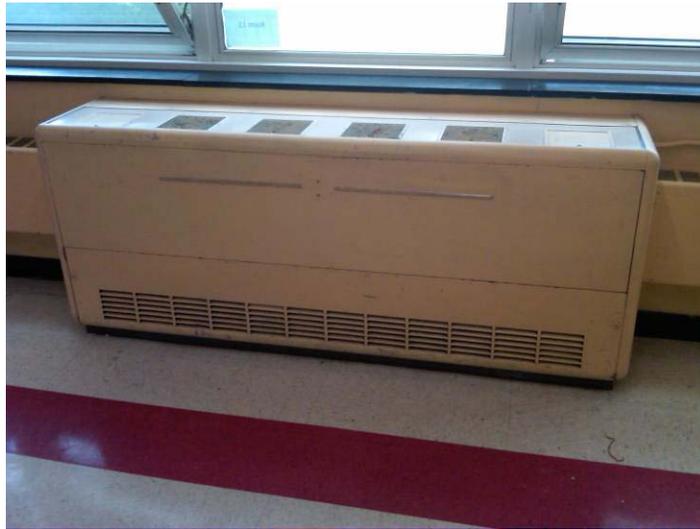
- Unit Ventilators in classrooms are a mix with approximately 50% of the units having been replaced in recent years and the remaining units being approximately 30+/- years old manufactured by Herman Nelson. The older units have exceeded their life expectancy and repairs are becoming more frequent. Although they have been able to obtain parts for repairs when needed, obtaining these parts will become more of an issue as more units fail and require replacement parts, these older units should be replaced.

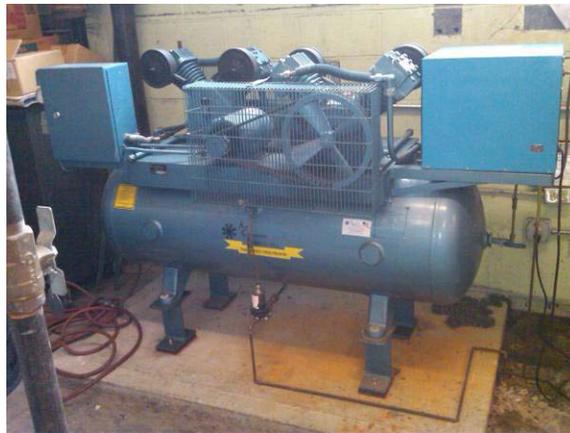
- The existing temperature controls in the school are a pneumatic the controls system compressor is new and in very good condition.

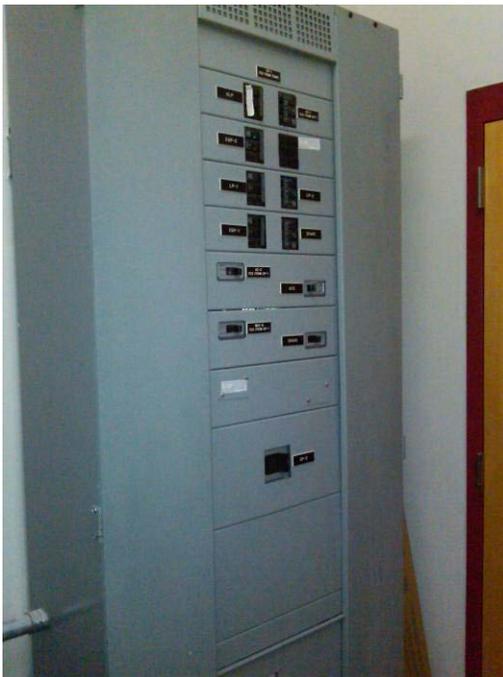
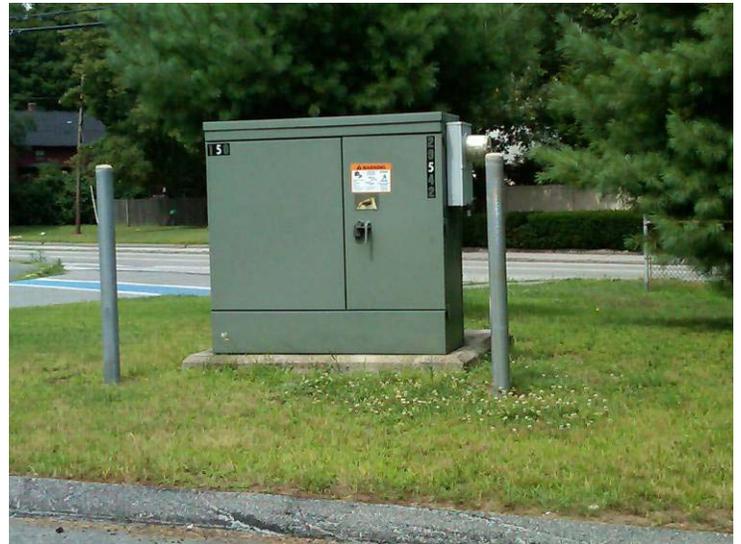
1. The building is served by a single electrical service rated 800 amperes, 208Y/120volts, 3-phase, 4-wire and is located in the main electric room. The service equipment consists of utility company pad mounted transformer believed to be a 150 KVA unit, with pad mounted utility metering equipment an underground feed to a 800amp Siemens main distribution panel located in the main electric room. The predominance of the main distribution equipment service equipment is new (1997) and in very good condition.

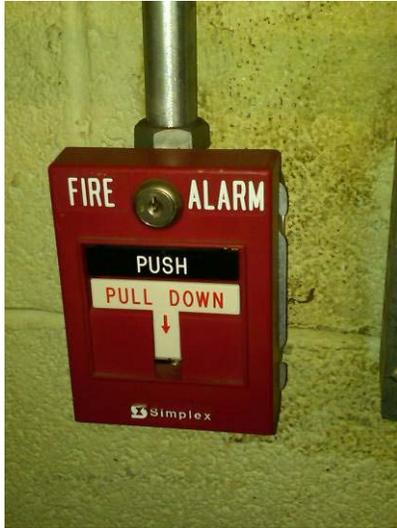
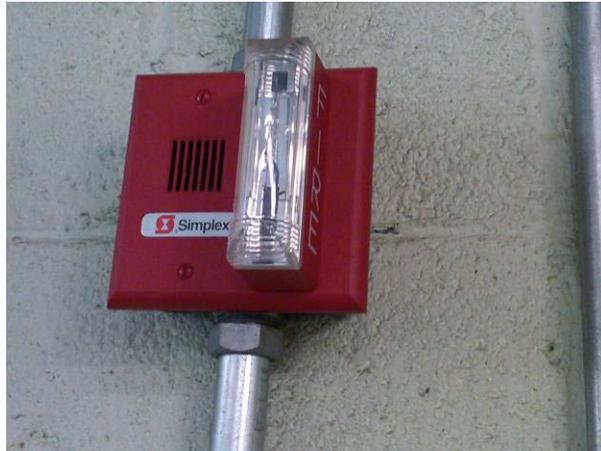
4. The fire alarm system is a Simplex 4100 addressable system. There are manual fire alarm pull stations, horn strobes located throughout the building. Heat and smoke detectors are present in select areas including smoke detectors in all corridors. The system appears to be newer in very good condition and it was noted by school personnel during the walk-thru that the system had been problem free.

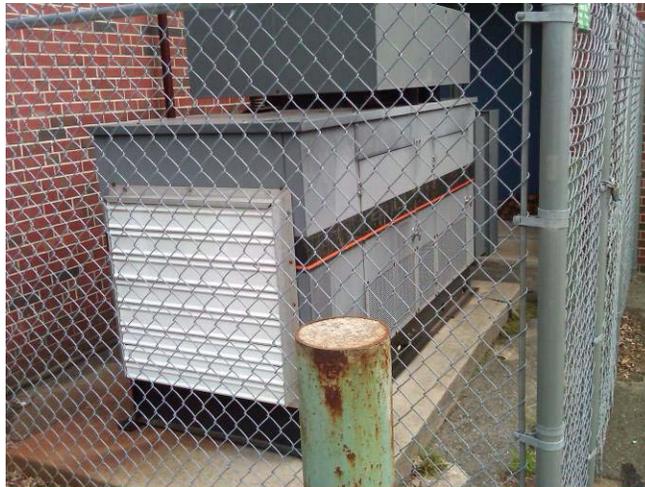
5. Site lighting is accomplished via building mounted wall packs and flood lights these appear to be in good condition.
6. There is currently an Olympian gas fired emergency standby generator that serves the facility. This unit is located outside at the rear of the school and appears in good condition. It was noted by operations personal that the unit was functioning without any noted problems. This unit serves the life needs of the school including emergency lighting.

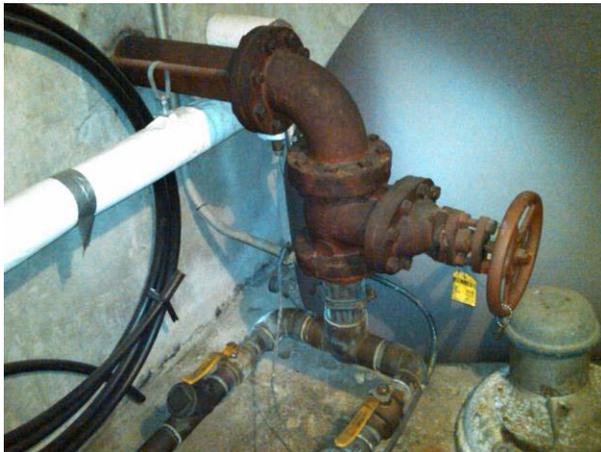
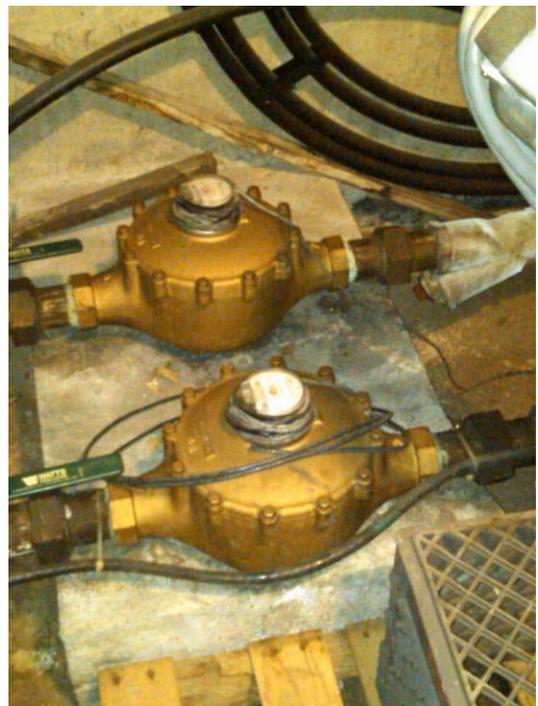
- a. Existing Domestic Water Service: The existing building is currently served by a 3" inch domestic water service located in the boiler/mechanical area. The domestic water service equipment includes a water meter and isolation valves. This water service currently serves all of the Schools domestic water needs. The water distribution system is original to the building and each subsequent addition.

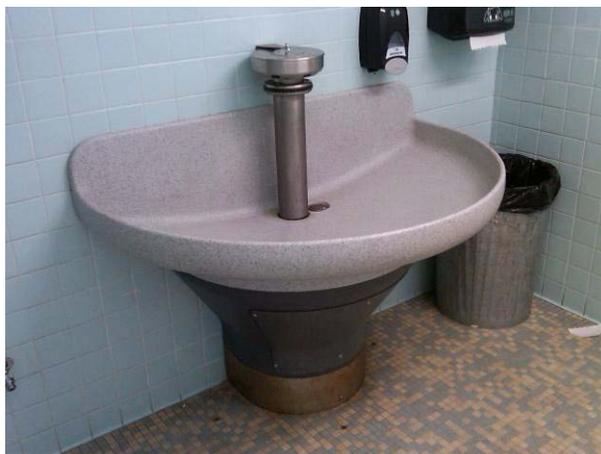
- Urinals are wall mounted vitreous china; manual flush valve, units appear to be in very good condition.
- Lavatories are wall hung half round wash stations with auto activation these units are newer and in good condition.

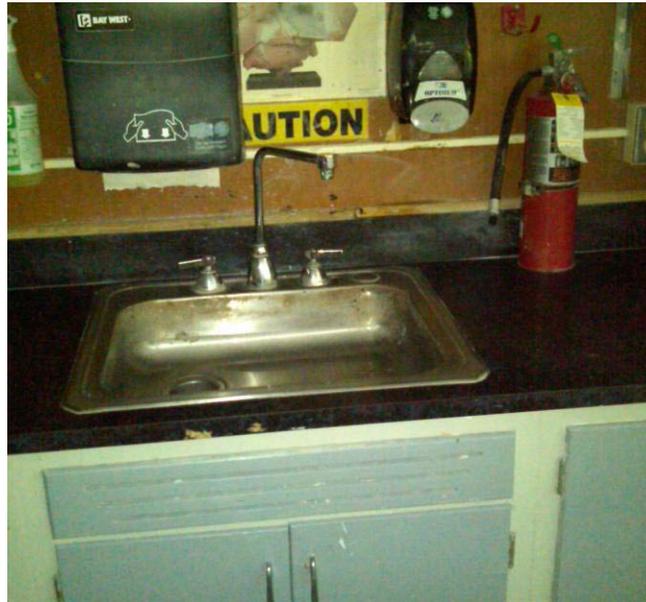
- Typical classroom sinks are counter top, stainless steel units with dual lever gooseneck faucets. All are non-ADA compliant.

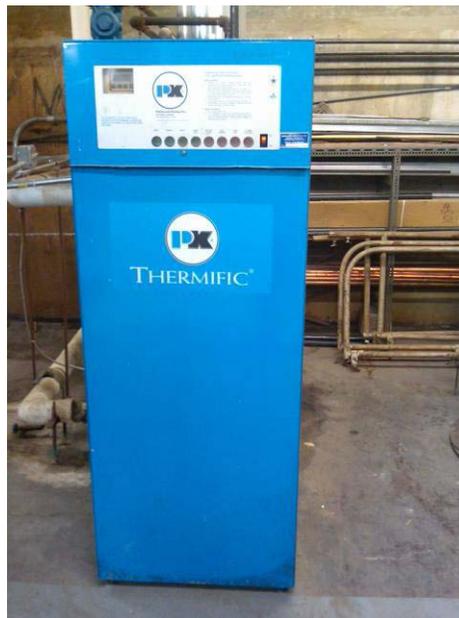
1. Existing Domestic Hot Water System: The Schools domestic hot water is generated by a PX Thermific gas fired boiler and storage tank with circulator pump. The unit appears new and in very good condition.

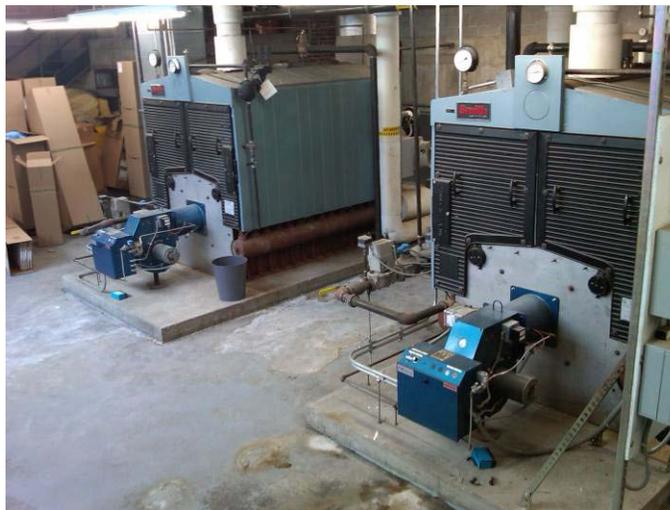
1. The existing building is heated by two hot water boilers. The two boilers are Smith with burners currently operating on Natural gas. These two boilers are approximately 7 years old and in very good condition. Both boilers are rated 3893 MBH.

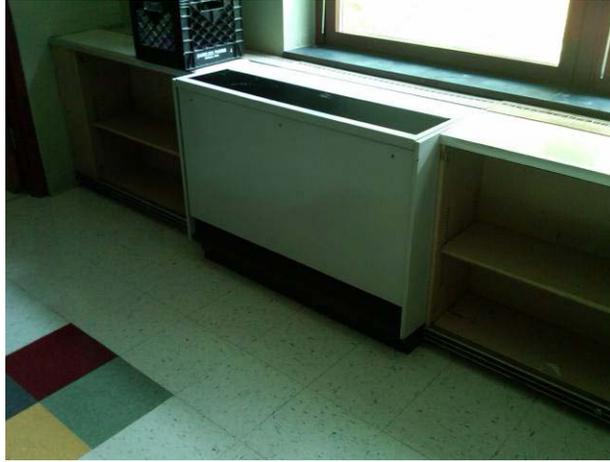
3. Unit Ventilators in classrooms are newer units, are approximately 7 years old having been replaced in 2003 and are in very good condition.

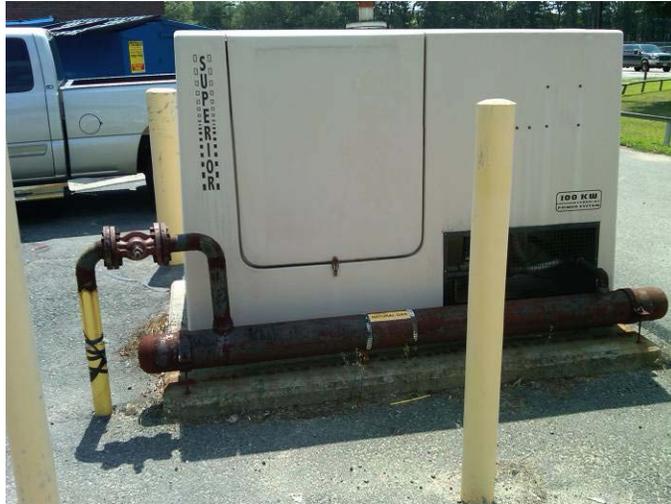
6. There is a 100KW superior natural gas emergency generator located at the rear of the building just outside the boiler room. This unit appears newer and in very good condition. We were informed that this unit covers all the life safety power requirements.

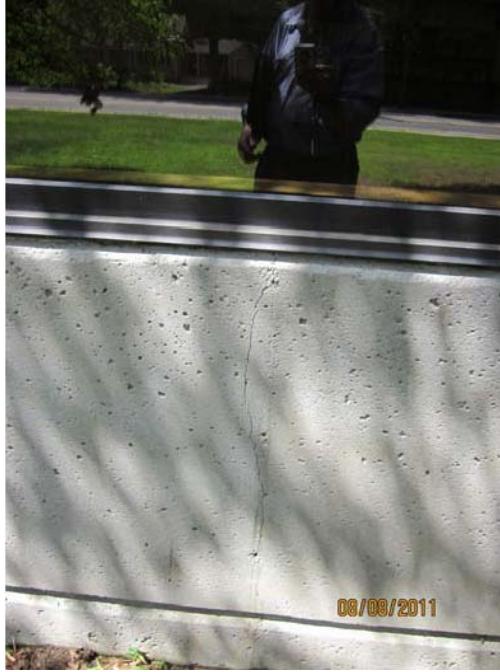
Photo 1

The single story structure appears to be supported on concrete foundation walls which are exposed to a height above grade of approximately four feet. There are numerous vertical shrinkage cracks in this wall, but no evidence of any settlement or differential settlement (Reference Photos 1 – 5).

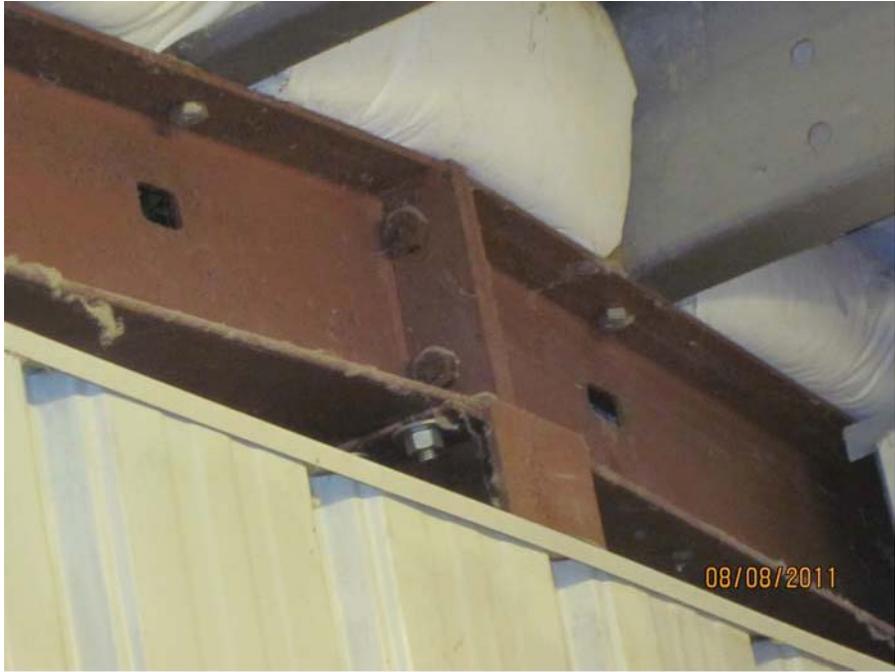
Photo 6

The small, prefabricated metal building is supported on concrete foundations. There were no obvious signs of any distress to either foundations or metal framing (Reference Photos 6-7).

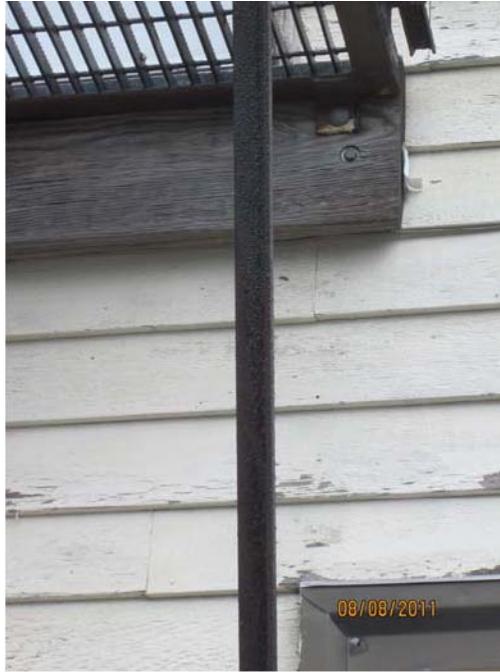
Photo 11

There are no obvious signs of any settlement or distress to main walls and foundations. There is however, decay at the foundation/brick interface at the front doors (Reference Photos 8-9). The metal fire escape is in poor condition (Reference Photos 10, 11, 12). The exterior sheathing at the rear is in decay. The chimney is in poor condition with missing brick and joint decay (Reference Photo 13). With the building technically having been unoccupied (used for storage only), any repairs would require compliance with the Massachusetts State Building Code (MSBC) and the International Existing Building Code (IEBC).

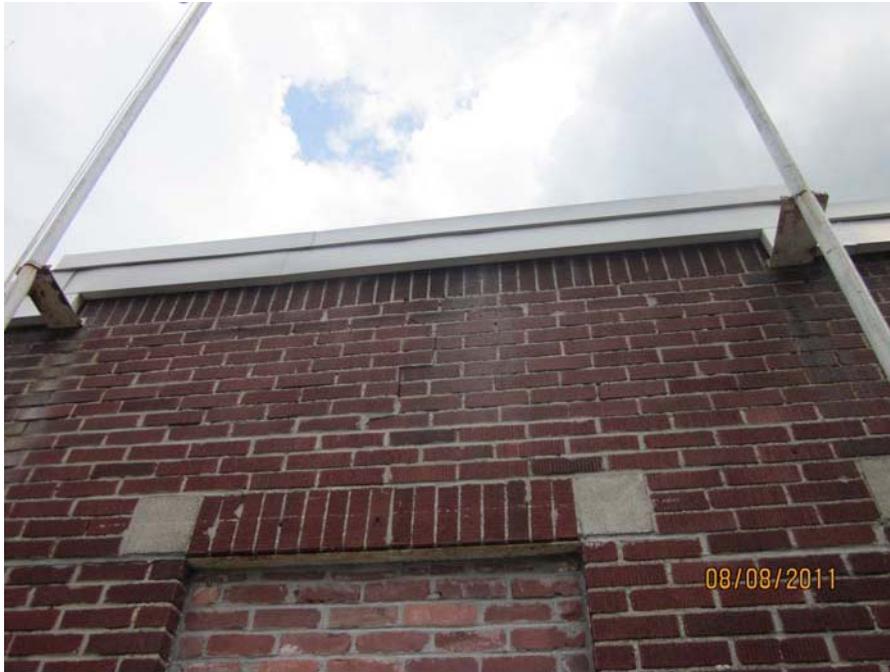
Photo 16

The exterior has been modified over the years and has brick, patterned block and parged block (Reference Photos 14, 15, 20, 21, 22 and 23). Its condition is poor, particularly at the front office elevation where there is severe corrosion to the steel lintels at the windows (Reference Photos 16, 17, 18 and 19).

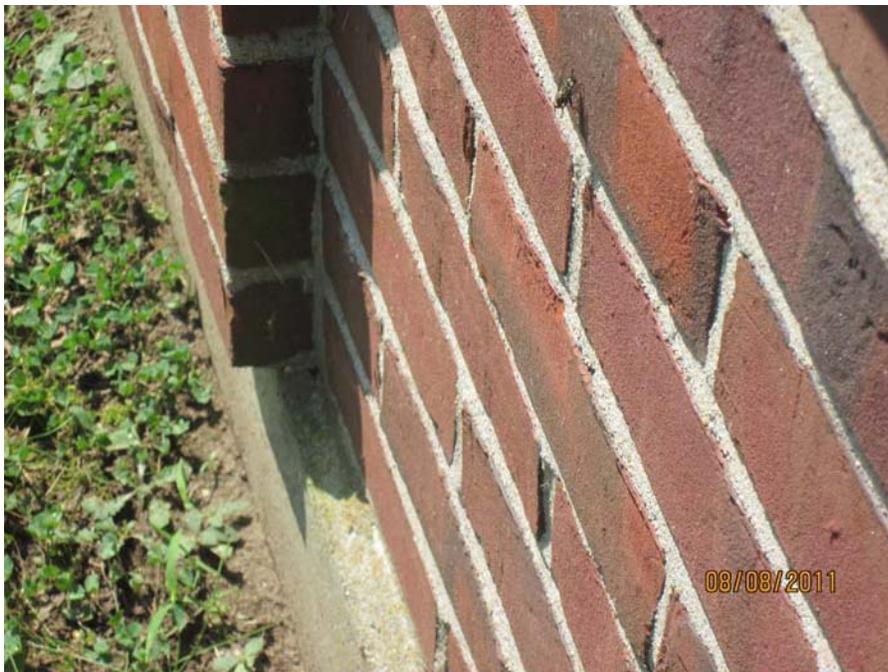
Photo 27

The exterior has brick veneer and there are localized conditions where cracked brick is evident (Reference Photos 26, 27, 28, 29, 30 and 31).

The exterior of the original buildings should be reviewed and repairs and re-pointing implemented.

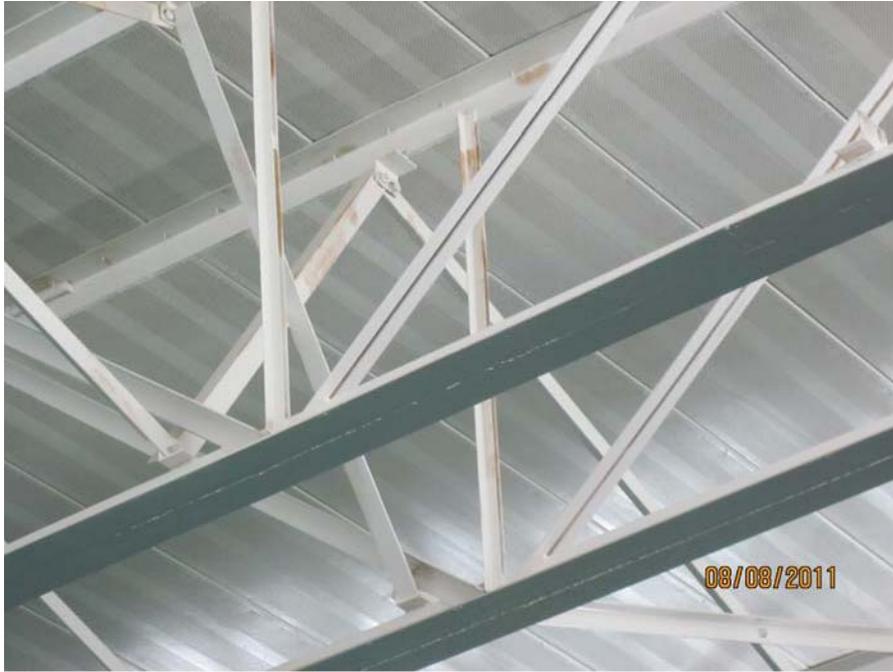
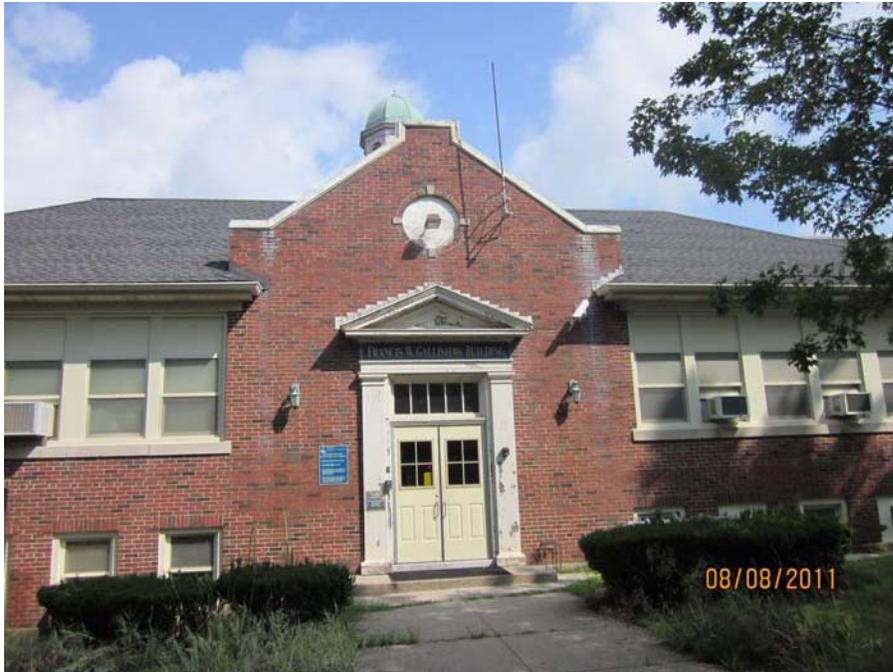
The 2003 addition consists of an auditorium, gymnasium and pool structure, and is in sound condition. There is discoloration to the steel roof framing above the pool (Reference Photos 32 and 33). This is as a result of the initial paint system and/or preparation of the steel. There are no structural concerns; however, careful consideration should be given to any repainting where treatment needs to ensure a properly prepared surface.
