Capital Improvement Study

Town of Seekonk

Massachusetts

Drummey Rosane Anderson, Inc.

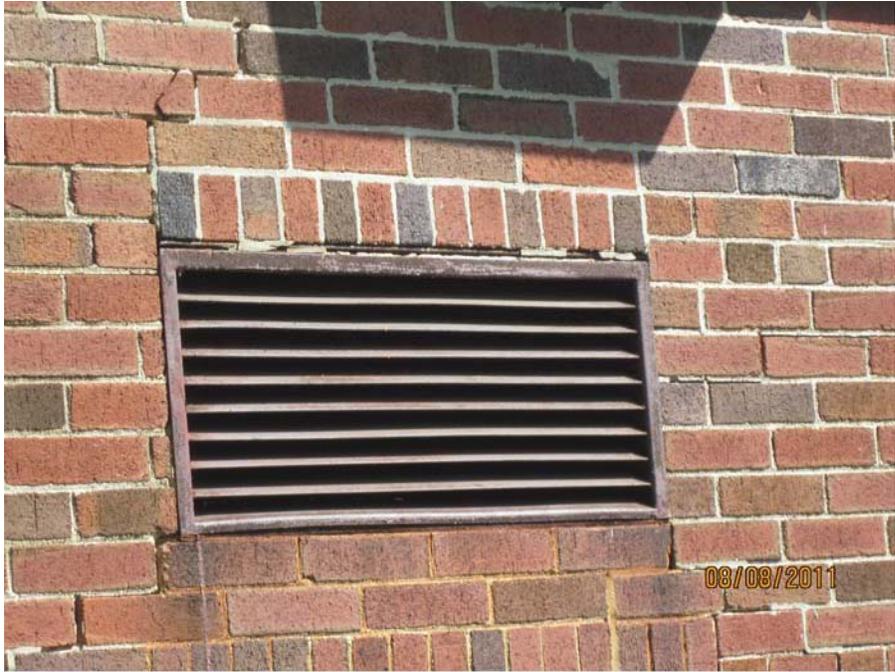
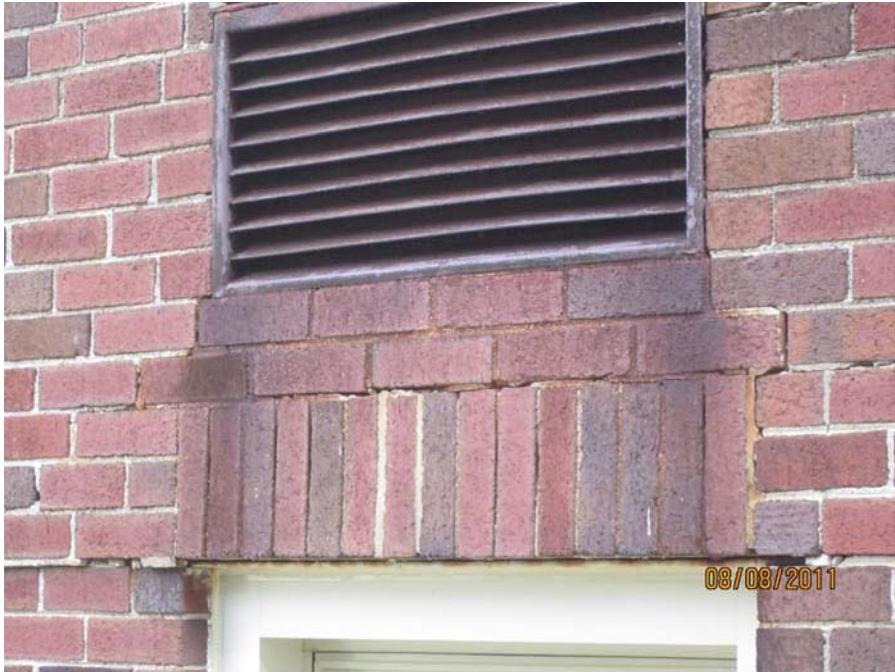
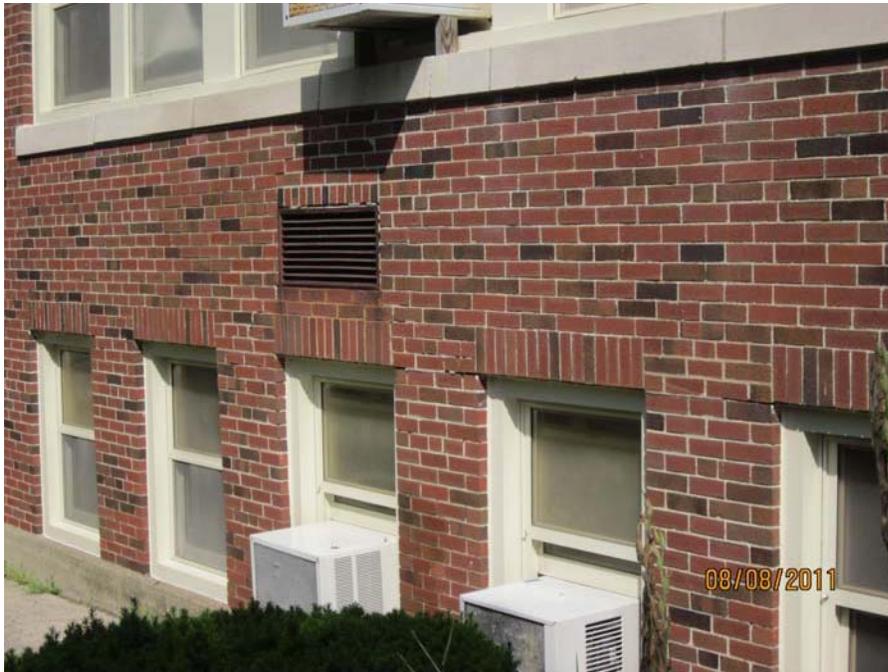
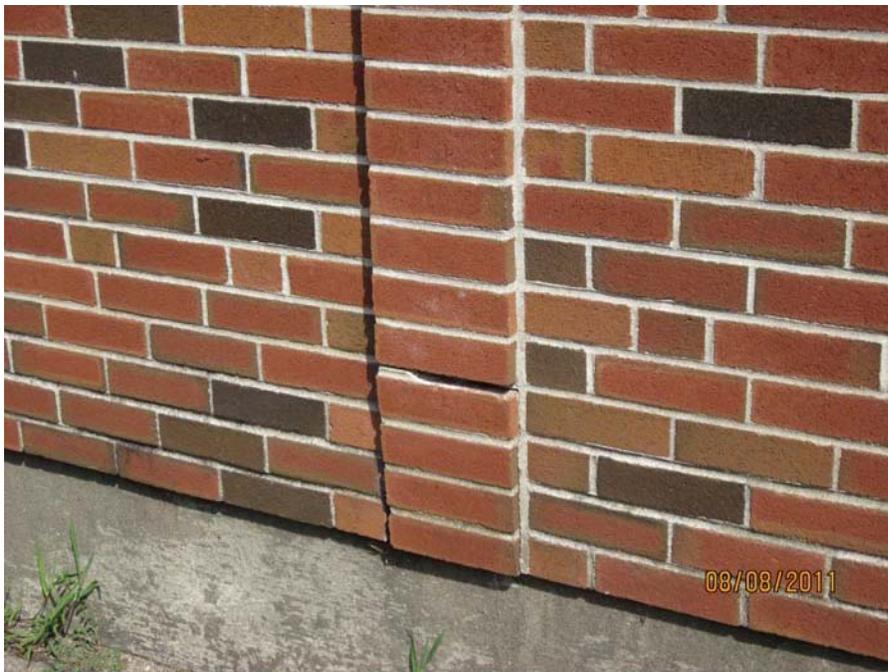
The exterior brick shows signs of severe distress and decay on the front elevation, particularly at unit ventilators (Reference Photos 34, 35, 36, and 37) and at exterior projections (Reference Photo 38). Concrete at the entrance steps shows spalling and decay (Reference Photo 39).

Attention needs to be paid to the exterior brick where localized cracking and joint distress is evident.

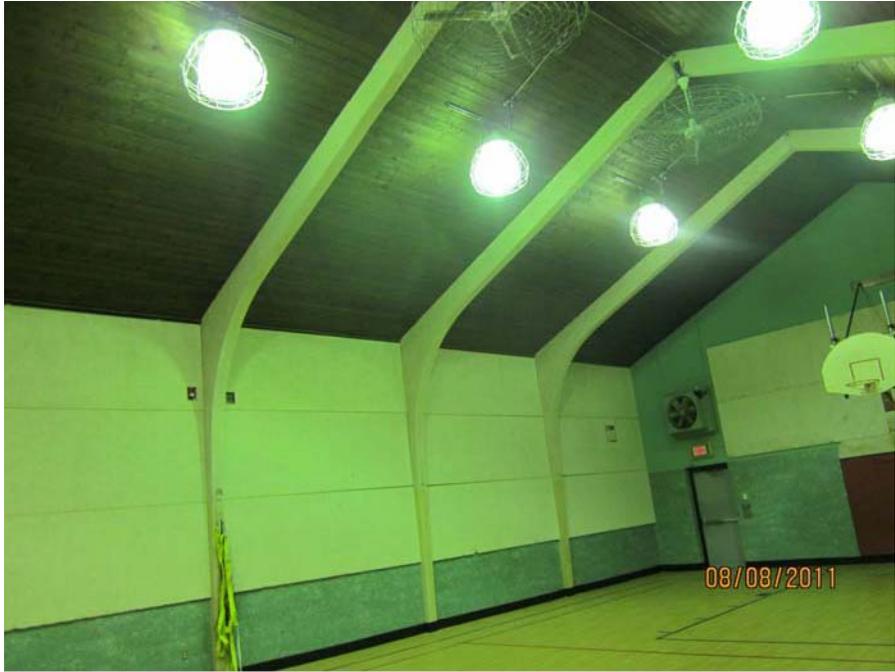
Photo 40

The wood framing at the roof (Reference Photo 40) appears to be in sound conditions as viewed from the access hatch. There does not appear to be any distress to the main timber members and wood sheathing.

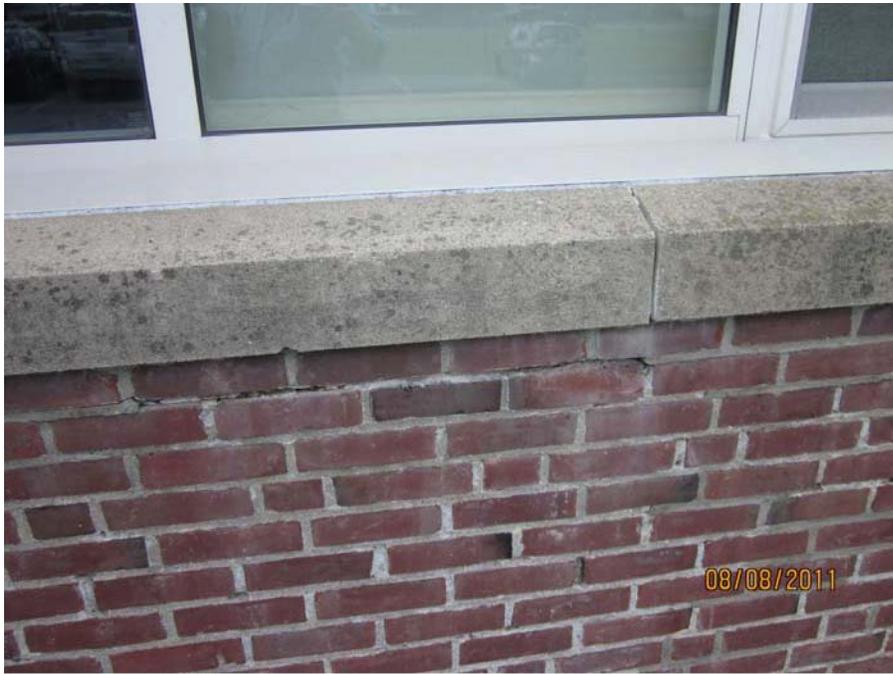
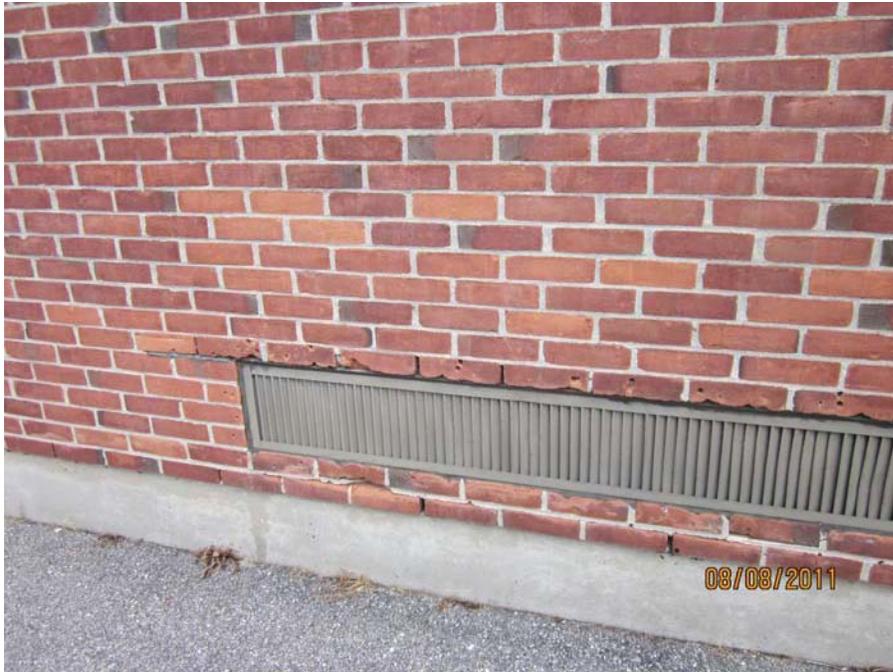
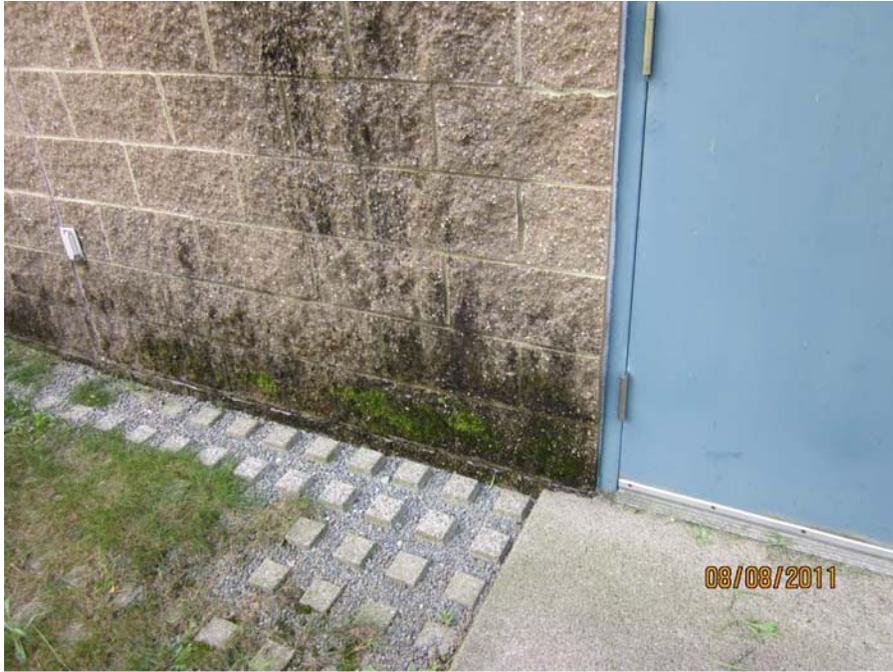
The exterior façade is in reasonable condition; however, there is some localized distress at brick mortar joints (Reference Photos 42, 43, and 44). There is evidence of staining and mold at some of the exterior split faced block (Reference Photo 45).

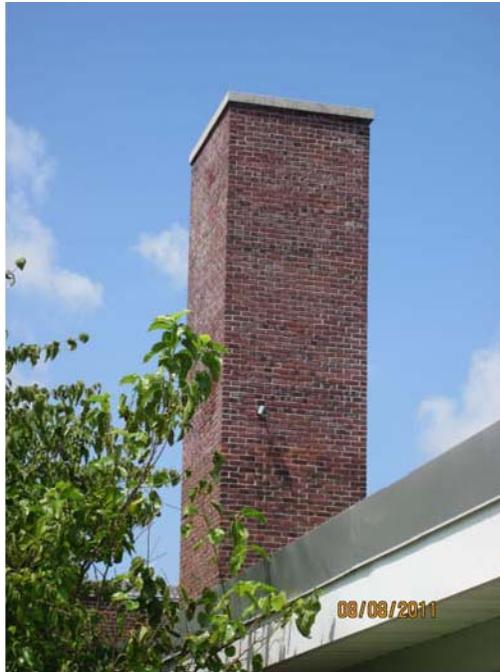
Photo 46

The brick chimney, as viewed from the ground, appears to be in sound condition (Reference Photo 46).
